*The BrickKicker is pleased to present this
professional home inspection report
for the property located at:*

**XXXXXXX
XXXXXXX, TN 3XXXX**

September 23, 2016

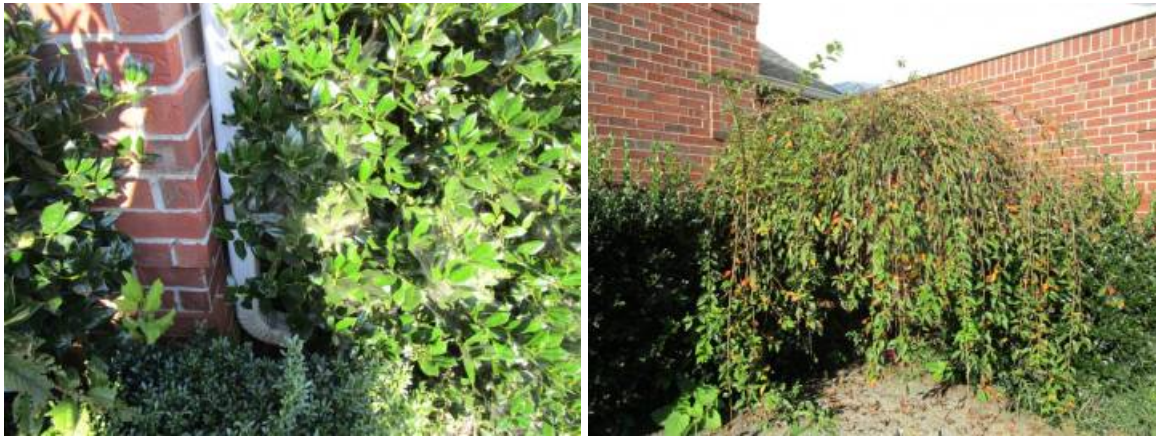
Shrubs were overgrown around exterior of home. Recommend cutting these back to maintain at least 8 to 12 inches of clear space between the structure and any vegetation to promote proper air circulation and help prevent damage from stains, moisture and insects.

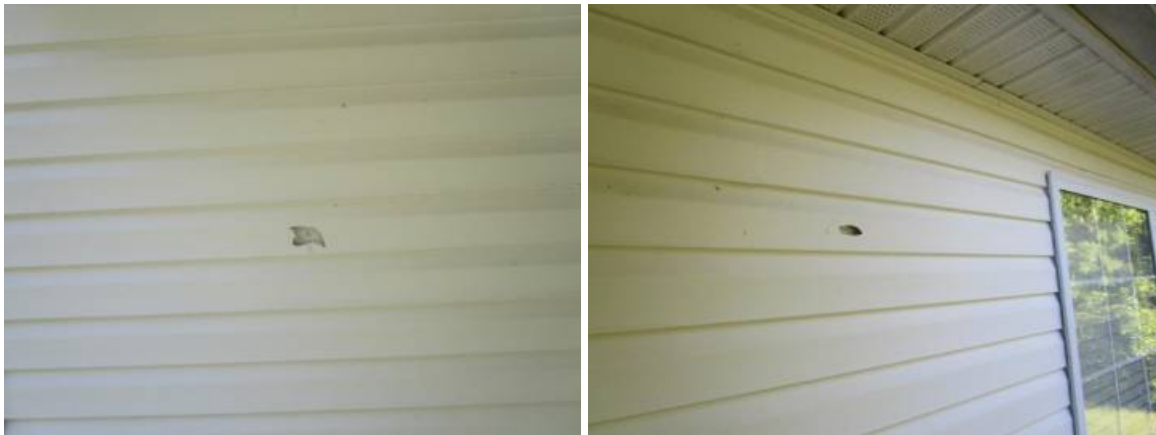
Vinyl Siding: Damaged siding materials were noted on one or more areas of the building. This may allow water damage to the underlying surfaces. Correction by a qualified contractor is recommended.

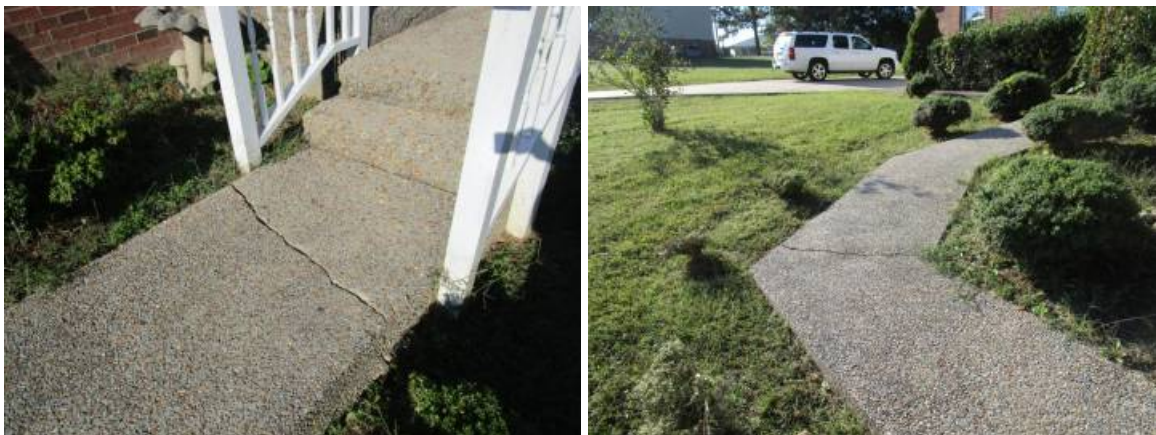
Typical cracking was noted at the building's walk(s). This is usually caused by shrinkage of the concrete as well as compaction of the soil under the walkway(s) over time, and usually occurs only in the first few years after the walkway(s) are installed.

Monitoring of the settlement is recommended.

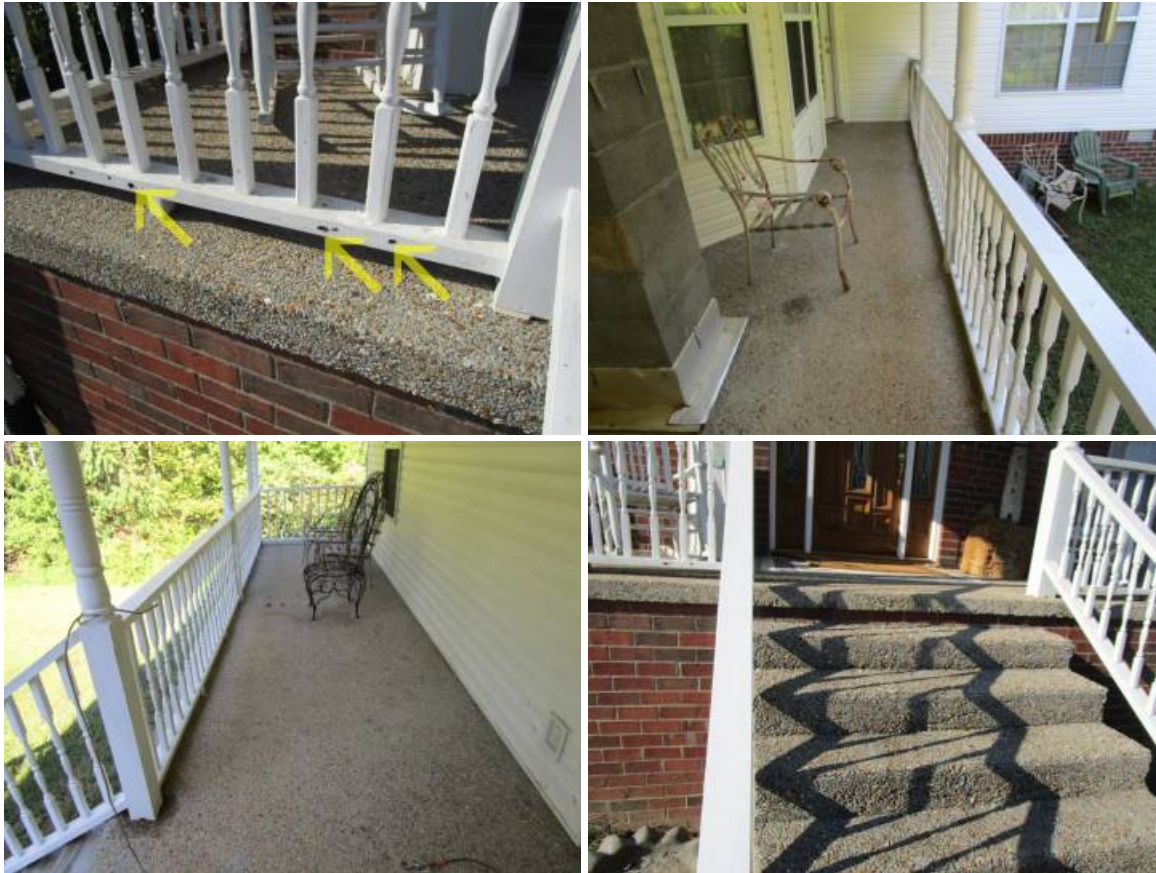
Wood: Evidence of possible wood destroying insects (e.g. termites, carpenter ants, powder post beetles) was observed in one or more areas. Further evaluation by a qualified pest specialist is recommended, as is repair of any damaged wood areas by a qualified contractor. Wood destroying organism investigation was beyond the scope of this inspection.

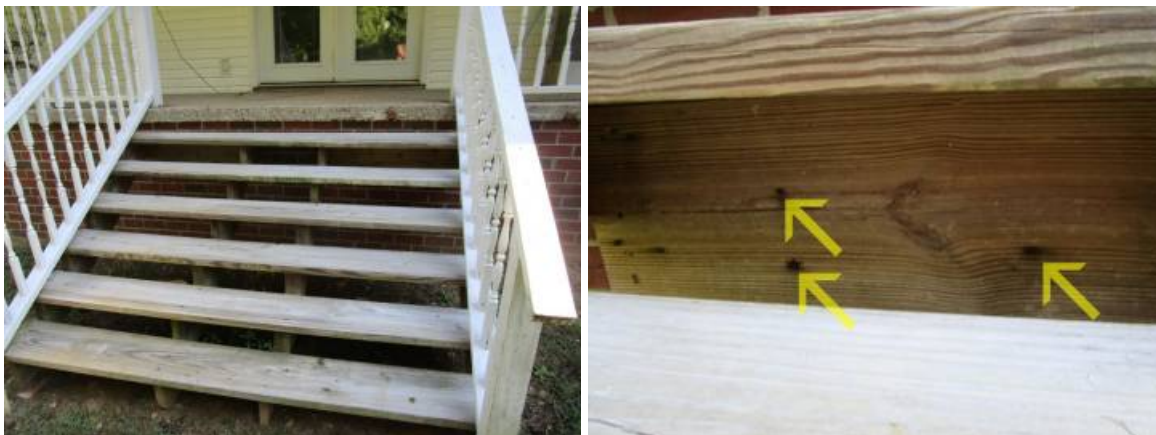
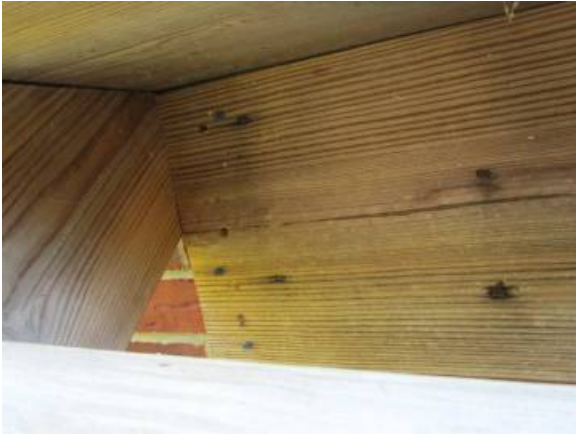
The ledger board for the back stairs appeared to be nailed to the house. The ledger board is an important structural component that should be properly attached to the main house (nails may allow it to pull away from the house). Recommend further evaluation and correction by a qualified contractor.

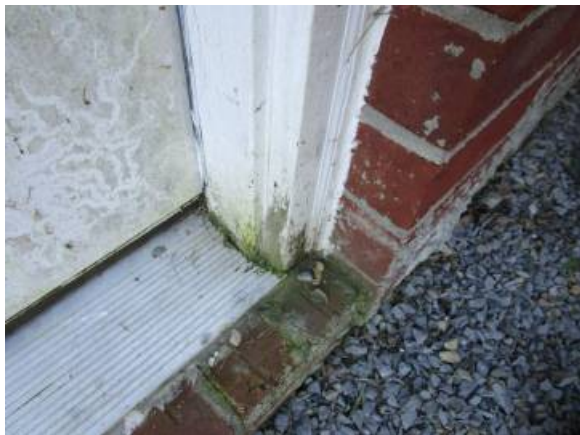
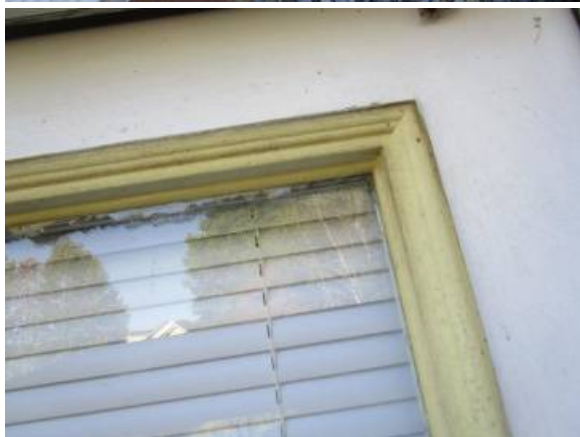
The basement exterior door appeared to leak water during a rain storm. Recommend further evaluation and correction by a qualified contractor.

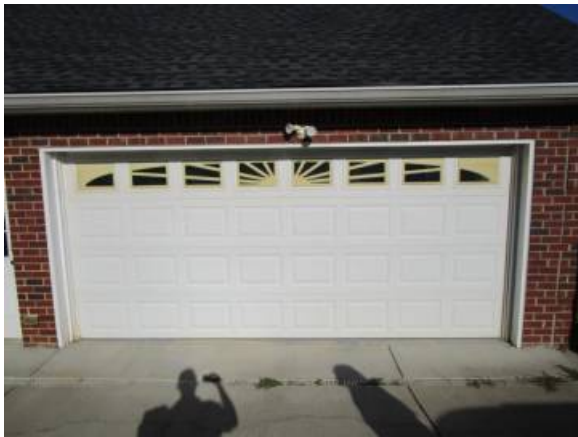
The bottom of the door was rusted. Proper repair and refinishing is recommended to extend the life of the garage door.

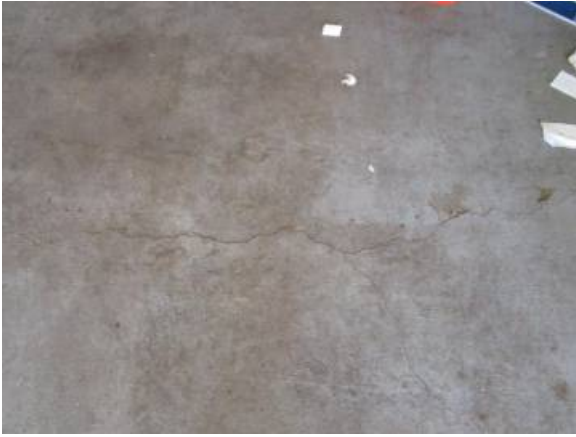
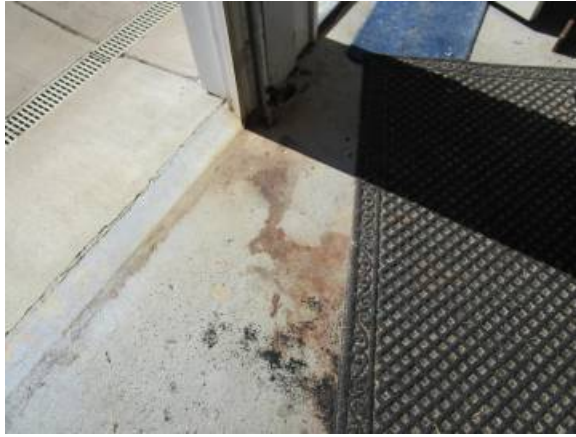
Drain Full of Debris

Some typical cracking of the floor was observed, which does not usually indicate a structural deficiency: monitoring of the cracking is recommended.

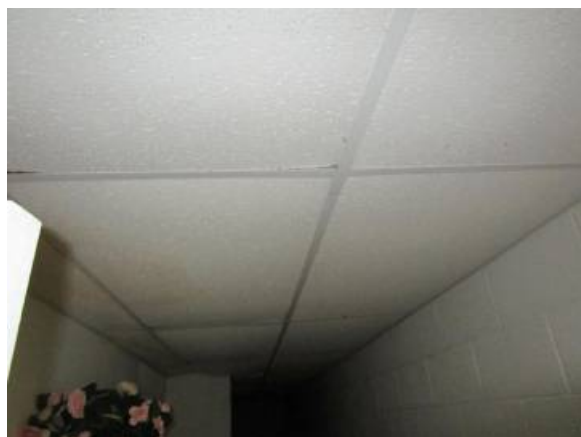
Staining (apparently from moisture) was observed in numerous areas of the basement ceiling: The staining was DRY at one or more areas when tested with a moisture meter. Recommend monitoring of the staining and/or checking with the current owner. It is also recommended to determine and correct the source of the staining if still active.

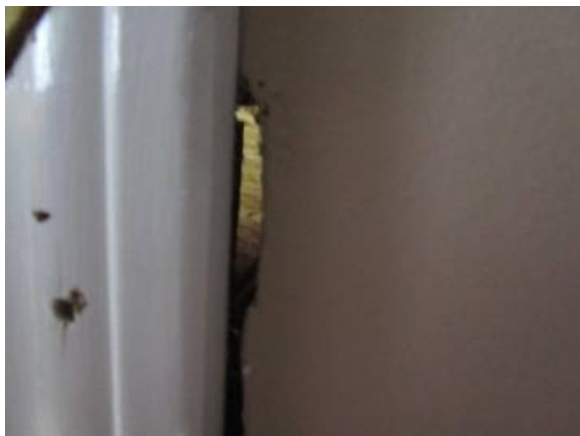
There was a gap between the wall and the door frame to the attic space above the garage. This gap will allow outside air into the living space. Recommend sealing the gap.

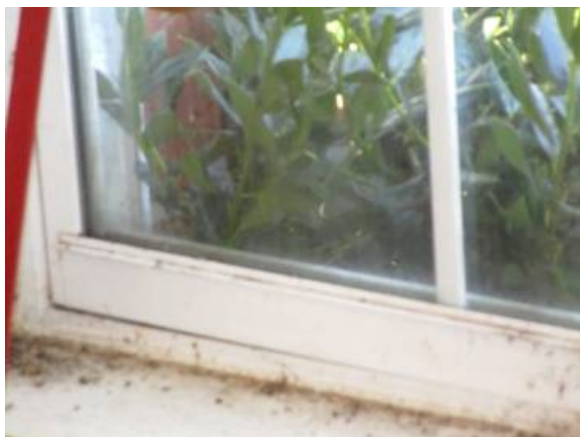
The garage window did not appear to be properly seated into the frame. Recommend further review and correction if necessary by a qualified window contractor.

The window sill in the basement bedroom appeared to be unfinished. There was a large gap running the length of the sill.

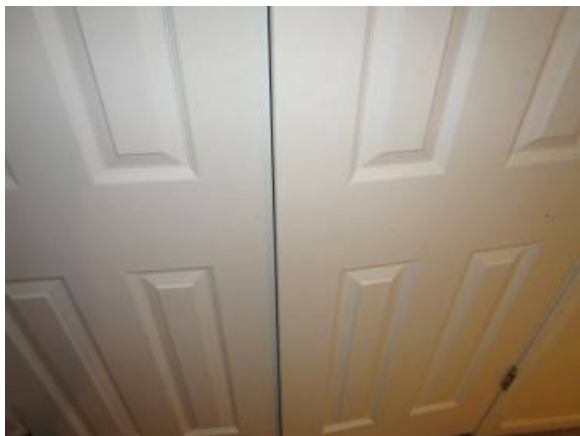
Missing door knobs on front and rear guest bedroom closet doors. Recommend adding door knobs for ease of operation.

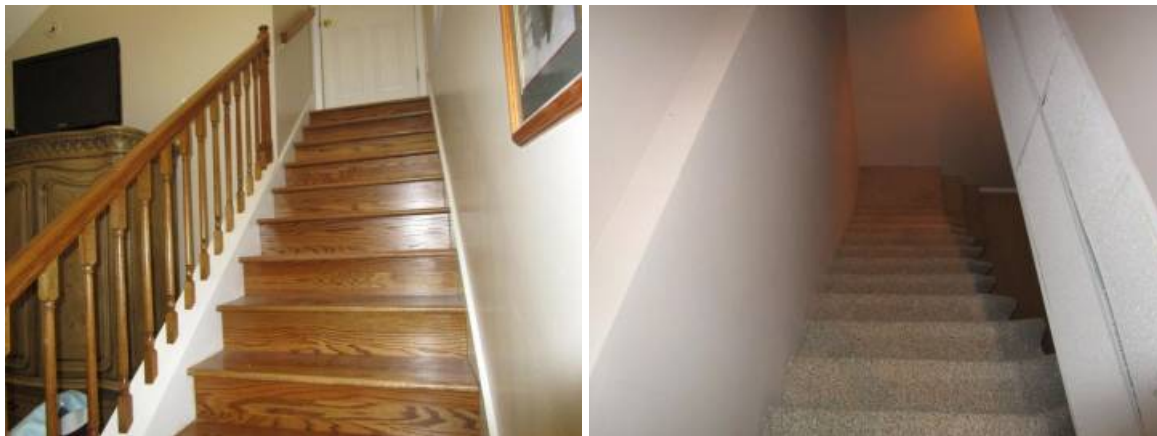
Modern standards require that a landing be installed on both sides of the door, especially if the door swings over the stairs. Recommend further review and correction by a qualified contractor.

Areas of the carpet were noted to be loose on the stairs leading to the finished basement. This may be a tripping hazard, especially on stairs or in hallways. Recommend properly re-securing or replacing all loose carpet.

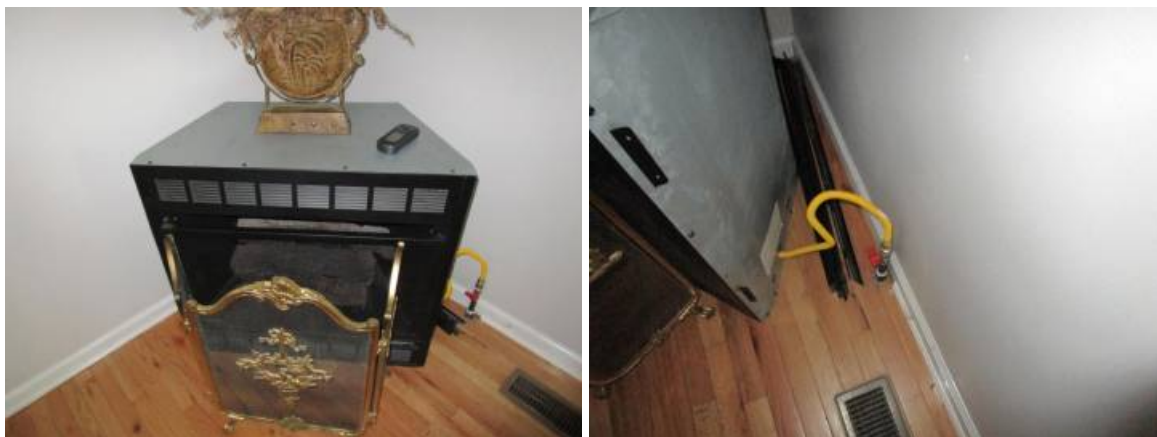
There was a gas log insert sitting on the living room floor connected to a gas line. Recommend reading the manufacturers instructions to determine if this is an appropriate and safe method to use this insert. If not, correction is required.

Recommend further review of the chimney and proper cleaning of the flu by a certified chimney sweep.

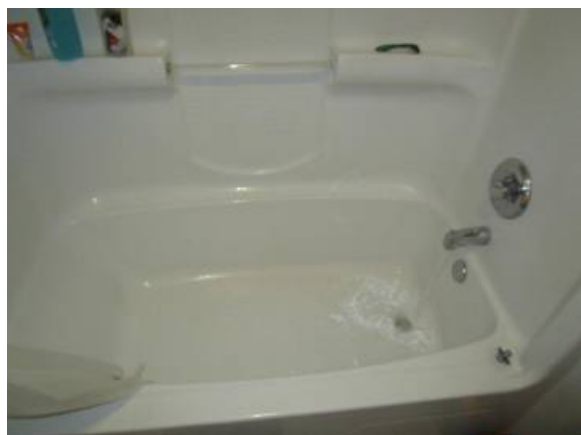
Proper caulking maintenance around the tub area is recommended to help prevent moisture damage to the underlying surfaces.

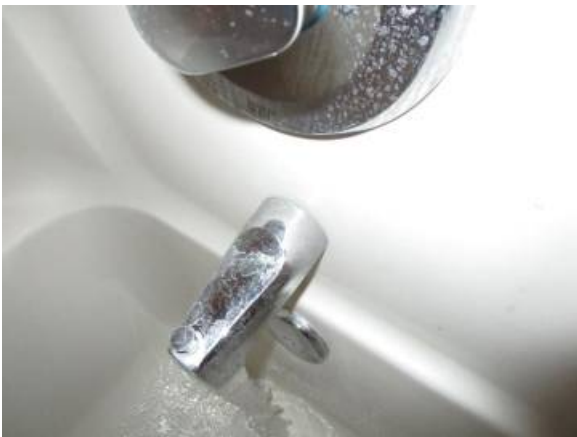
There is a gap between the tub spout and the wall surround. This location is an excellent area for water to entry the wall cavity. Sealant is recommended in this area.

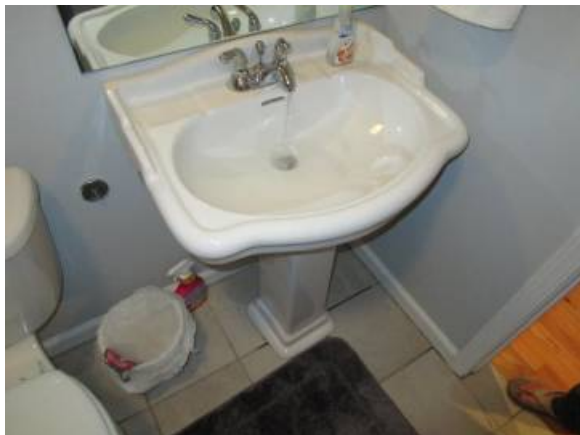
The sink was loose. Recommend properly attaching the sink tightly to the wall for safety and to prevent leaks from developing.

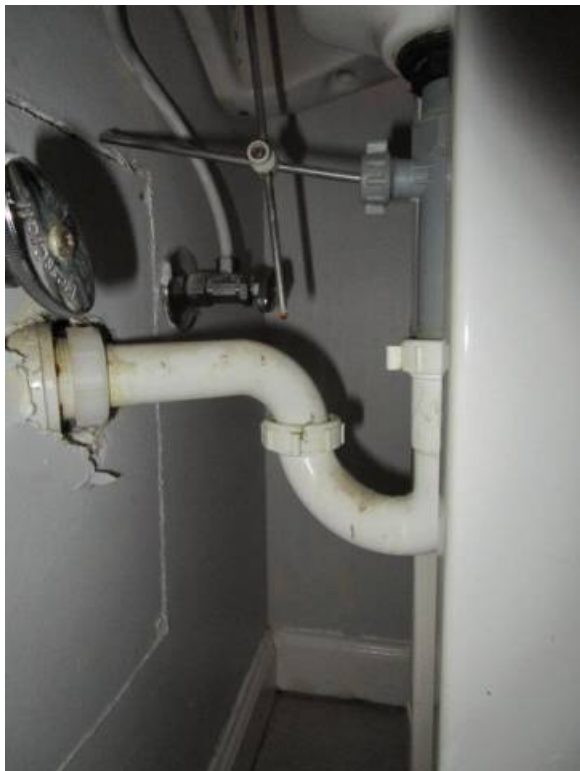
Leaking was noted under the sink from the waste line and/or other piping. Correction by a qualified contractor is recommended.

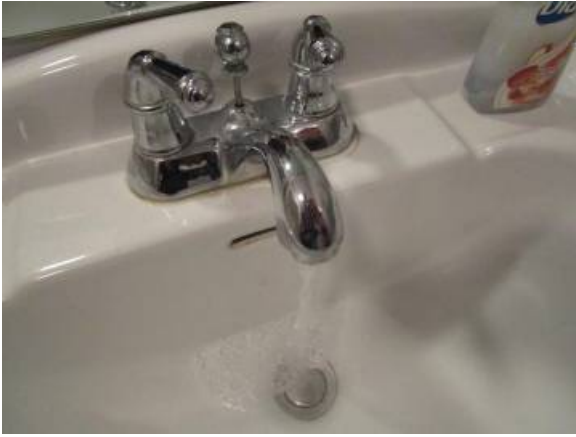
The water pressure was lower than normal which can be caused by older piping or simply a clogged aerator. Further review by a qualified plumber is recommended.

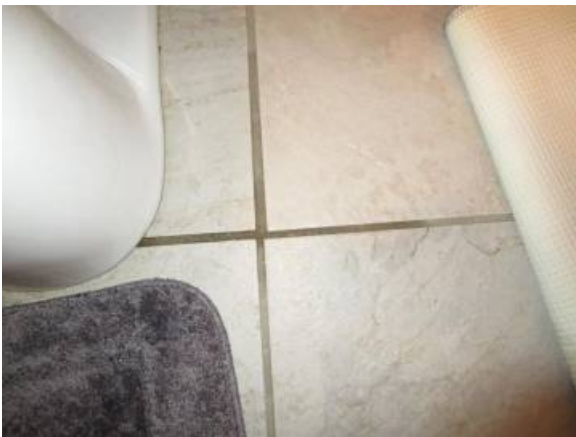
The flooring at the base of the toilet was wet when tested and the toilet appeared to be leaking at the base (will probably need a new wax seal). Correction by a licensed plumber is recommended.

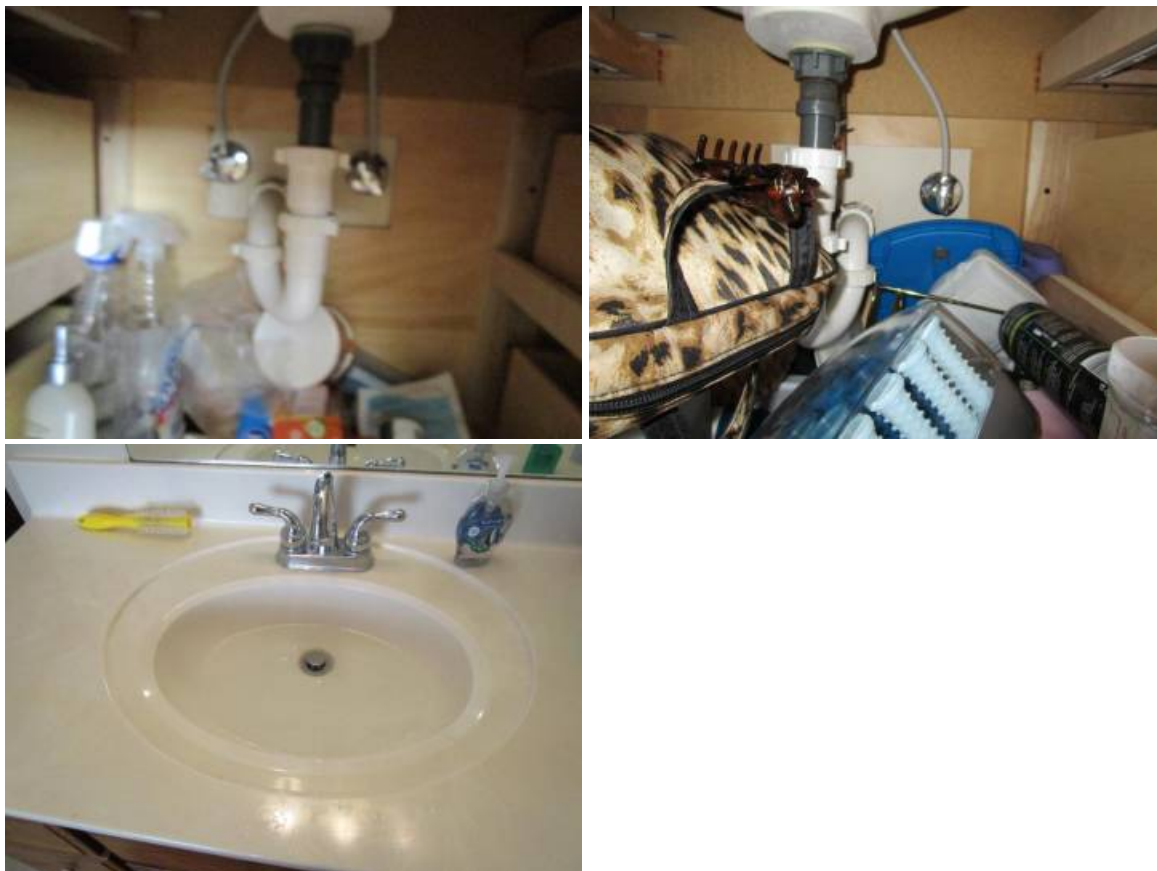
The sink drains slowly. There are several things that can cause this, including the accumulation of hair and soap scum in the drain piping. Drain opening chemicals can sometimes help, but often provide only temporary relief. Further review and correction by a qualified plumber is recommended.

The drain/waste piping below sink was not fully visible because of stored personal items. Defects may be hidden behind by the stored items, therefore careful review of this area during the final walk-through is suggested.

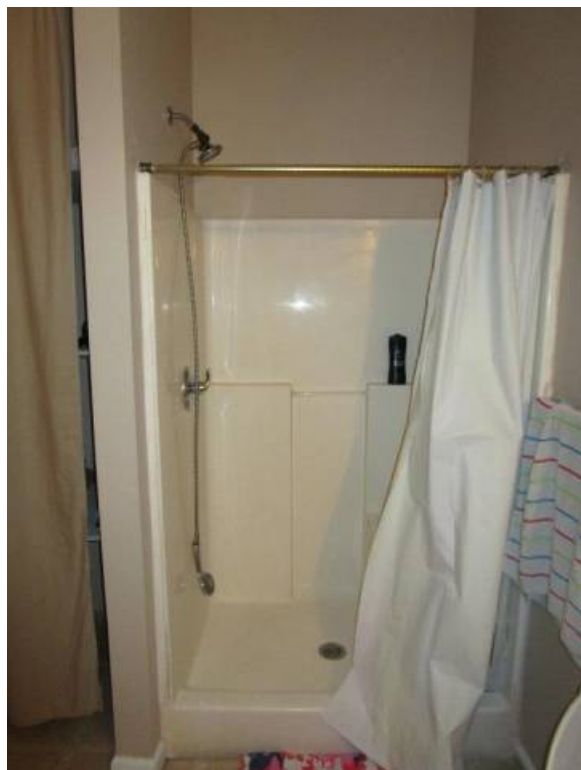
Staining (apparently from moisture) was observed around the top of the shower wall: The staining was DAMP or WET at one or more areas when tested with a moisture meter. This indicates the probable presence of one or more leaks: recommend that the source of the moisture be determined and corrected by a qualified contractor.

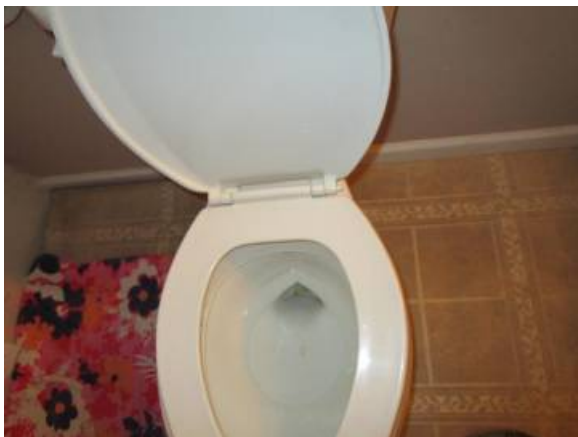
The toilet fixture appeared to be loose at the floor. This condition can cause the toilet to leak at the base, potentially causing damaged and/or rotted flooring. Proper correction by a qualified contractor is recommended.

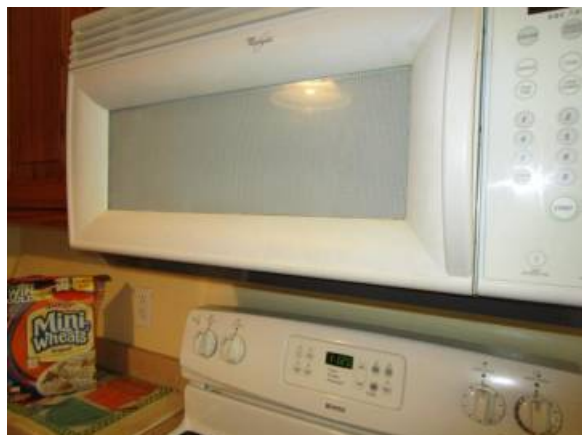
The ventilation light did not operate which may indicate a burned out light bulb or may be due to other reasons. Recommend checking with the current owner and/or further evaluation by a qualified appliance technician.

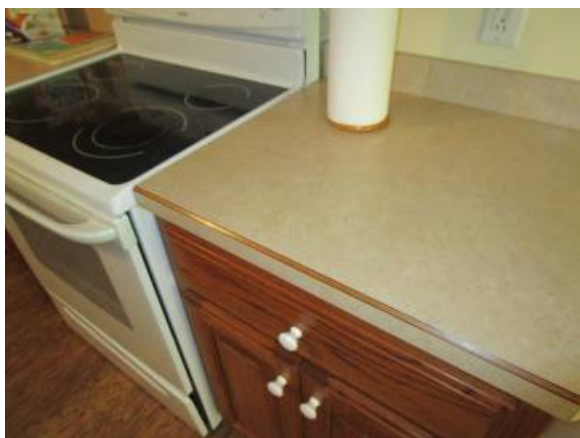
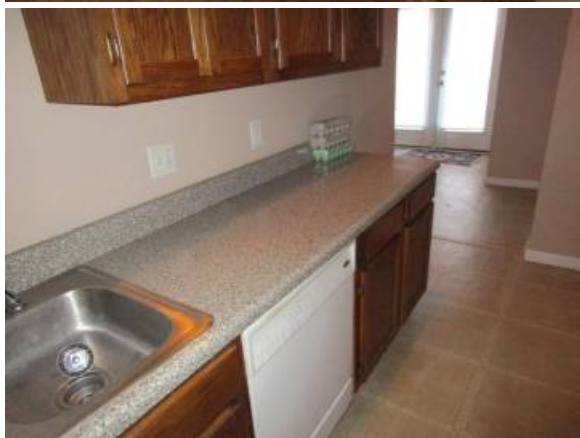
The countertop(s) were loose at one or more locations in the basement kitchen. Recommend properly securing all countertops to the base cabinets.

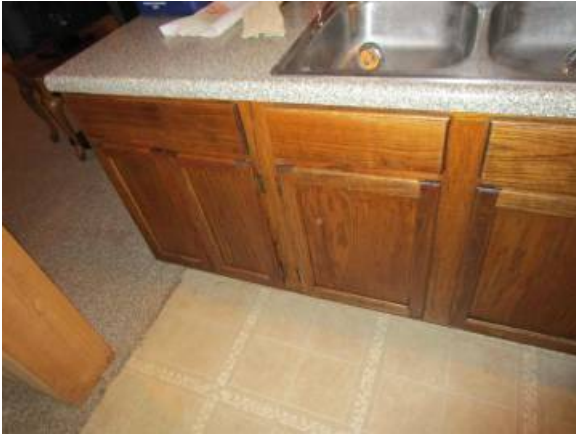
Staining was observed under the sink in the basement kitchen: The staining was DRY when tested with a moisture meter. Recommend monitoring of the staining and/or checking with the current owner. It is also recommended to determine and correct the source of the staining if still active.

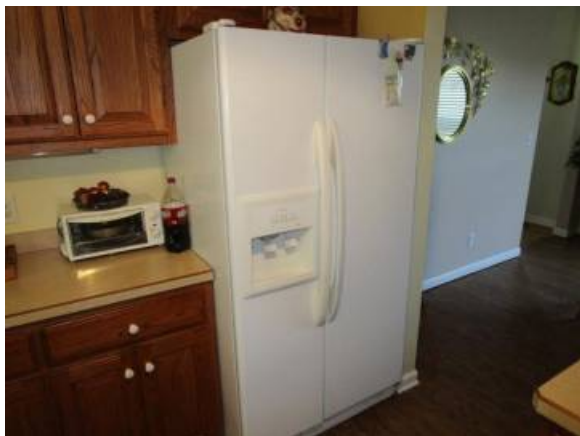
Refrigerator: The ice dispenser did not appear to operate properly. Recommend further evaluation and correction by a qualified appliance technician.

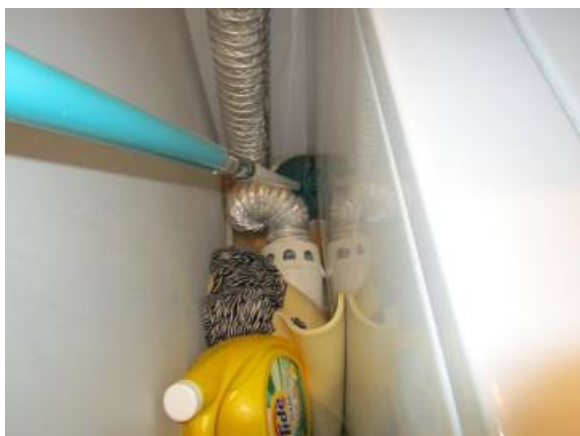
Clothes Dryer: The clothes dryer vents into the laundry room. This adds excess humidity and, if it is a gas dryer, carbon monoxide into the house. Recommend the clothes dryer be vented to the exterior of home.

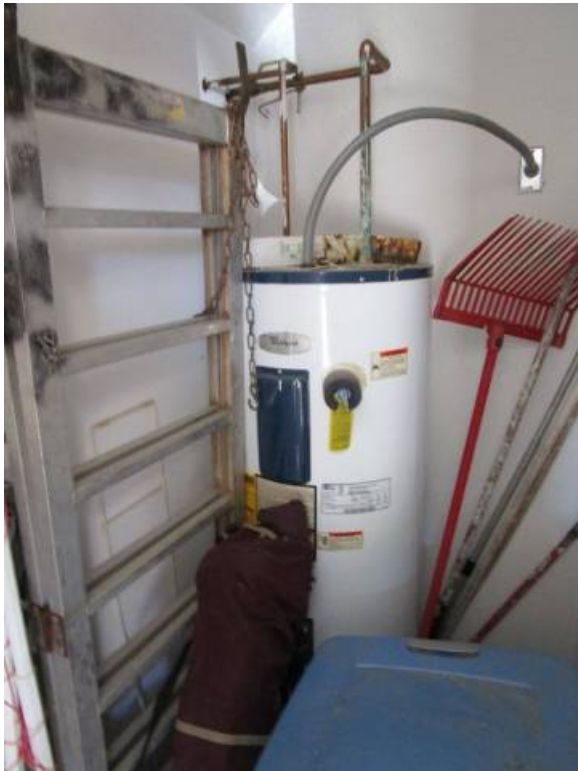
The temperature and pressure relief valve was not properly piped. In an emergency, this valve will discharge scalding water. Recommend installing piping so that the valve will discharge to a point about 6 inches from the floor.

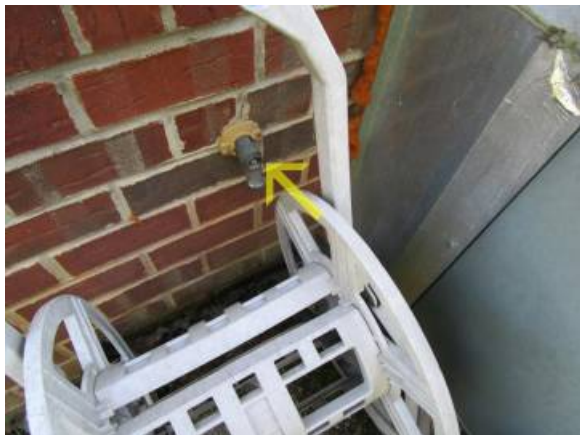
Garden Hose Bibb(s): One or more of the garden hose bibb handles was missing and the hose bibb(s) could not be tested.

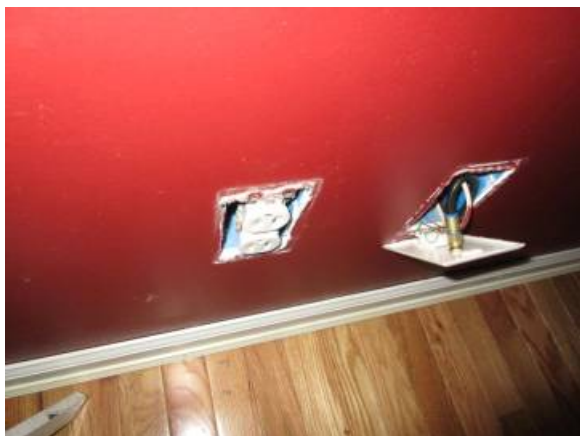
"Missing Cover Plate" Location(s): Living/Dining Room.

One or more electrical outlets were observed that are missing protective cover plates. Recommend installation of proper cover plates at all receptacles to avoid shock hazard from exposed conductors.

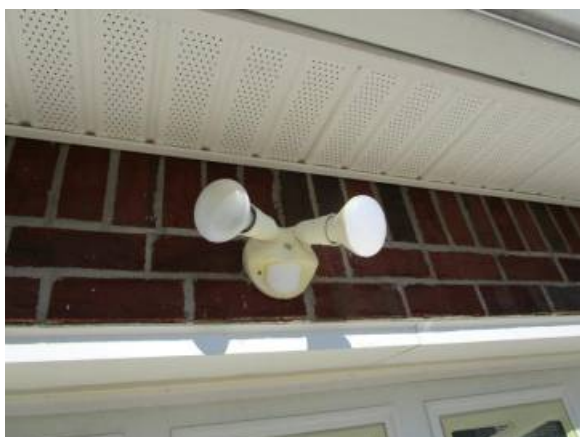
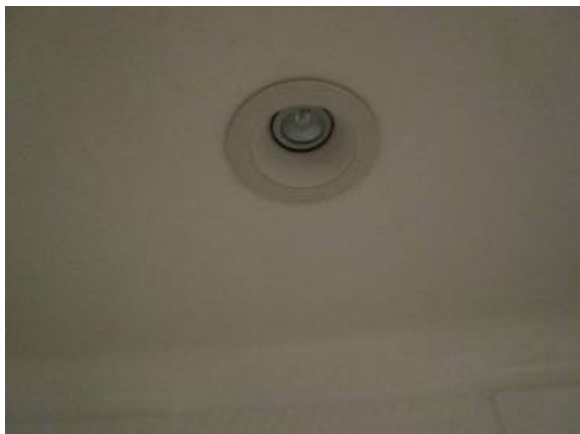
Numerous lighting fixtures did not operate at the time of the inspection using normal controls. This often indicates that light bulbs may be burned out. Recommend checking with the current owner and verifying operation before the closing.

The office fan rubbed the light fixture when turned on making the fan unusable. Recommend further evaluation and repair.

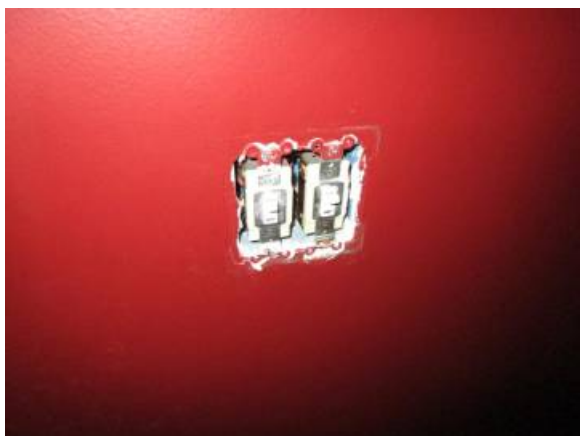
Switches: One or more electrical switches were observed that are missing protective cover plates. Recommend installation of proper cover plates at all switches to avoid shock hazard from exposed conductors.

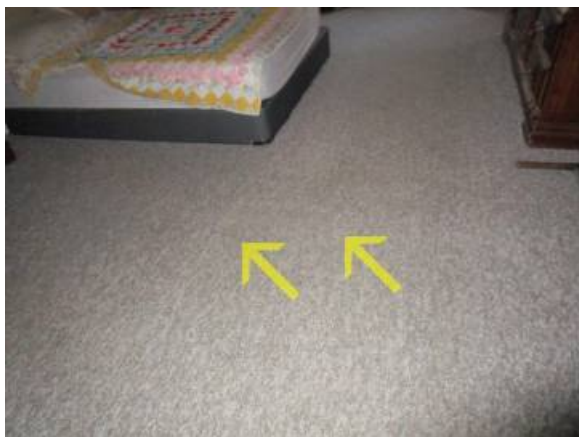
The floor appeared to be heaved in the basement bedroom. However, the carpet covered the area and it was impossible to confirm if it was cracked or just uneven. This may be caused by settling of the foundation walls, underground plumbing, or other reasons. The floor usually has very little impact on the structure and the heaved areas of the floor may be corrected as desired.

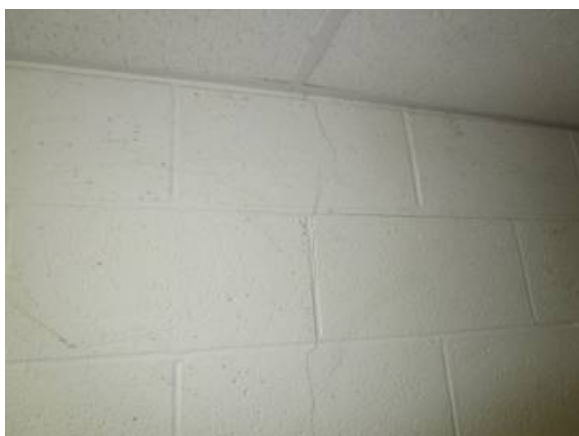
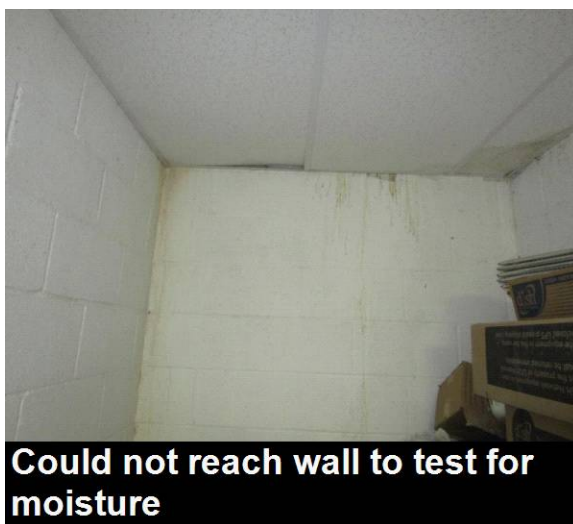
Dampness was noted several areas, as tested with a moisture meter. This can increase the risk of insect infestation, mildew, and rot. Recommend locating and correcting the source of the dampness, which may include improving exterior drainage and/or sealing of foundation cracks.

The HVAC unit was off at the time of the inspection, which will cause the humidity level to increase. This could contribute to the musty odor and possible fungal growth. Recommend keeping the HVAC running to reduce the humidity level.

Could not reach wall to test for moisture

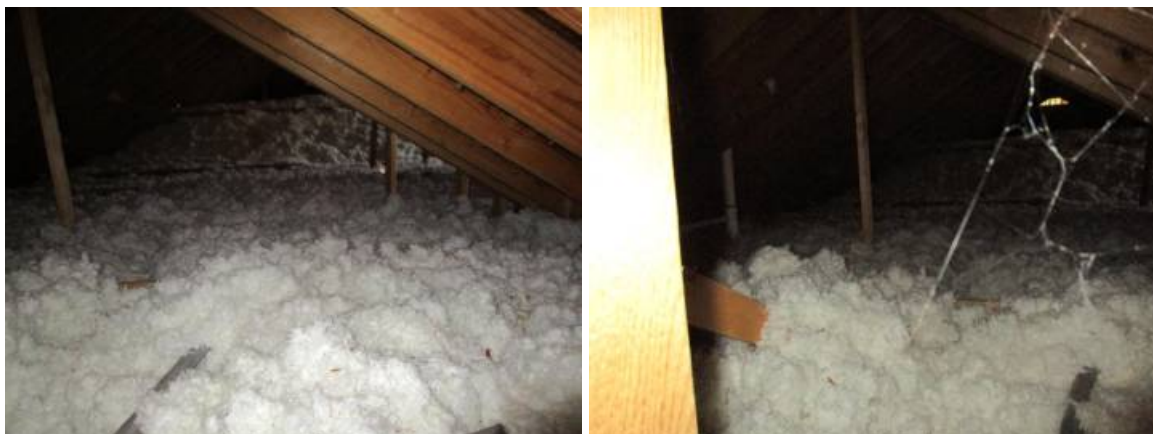
Insulation appeared to be missing in some areas of the attic space(s). Recommend adding insulation to achieve a consistent total depth of 16 inches (the current standard) which will help to provide improved energy efficiency and cost savings.
