# PROPERTY INSPECTION REPORT

**Prepared For: Happy Buyer**

**12/26/18**

**1001 World Center Dr  
Naperville, IL  
60564**

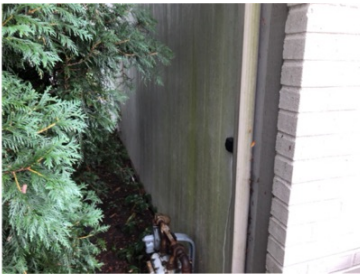
Portion(s) of the siding were noted to have some amount of mildew and/or algae growth. This is not unusual in exterior areas that don't get sunlight exposure. It is usually just a cosmetic issue, but can contribute to accelerated deterioration and should be removed to extend the expected life of the siding.

Algae Growth

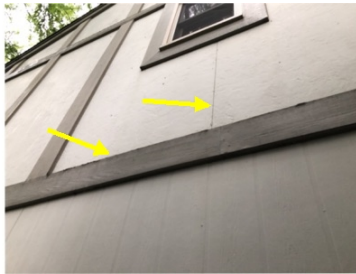
Failing paint or stain coatings were observed on areas of the wood siding. If not corrected, deterioration of the bare wood could occur. Proper refinishing and caulking is recommended. --

Minor Paint Failure

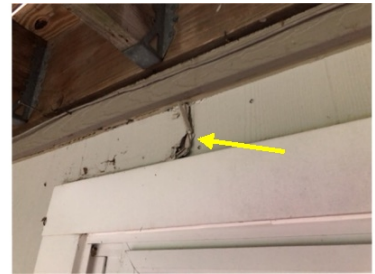
Loose/Damaged Siding

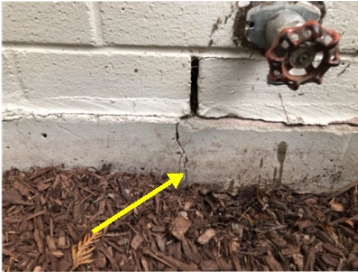
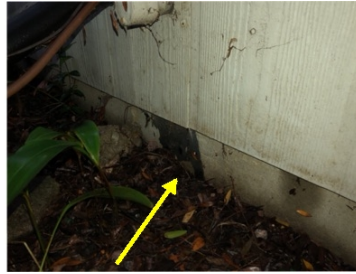
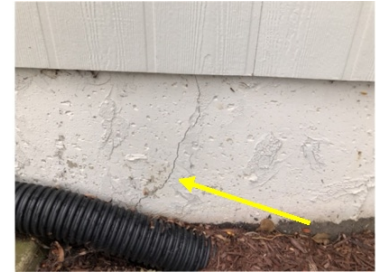
Common cracking was present on the exterior and visible portions of the foundation. If there is a basement or a crawl space, additional notes may be present in that section of this report.

Common Foundation Crack(s)

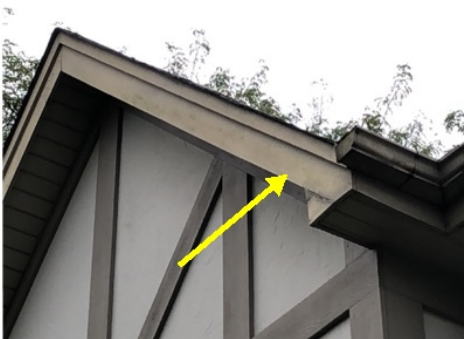
Paint Failure/Fading

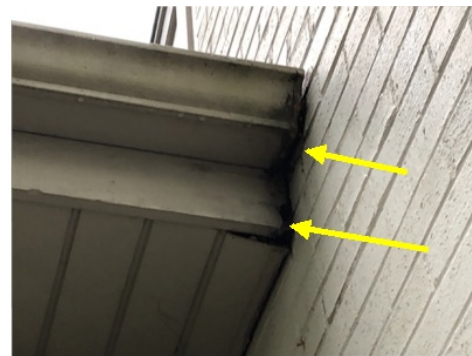
Deteriorated soffit and/or fascia material was noted around the home. This may allow water damage to the underlying surface structure and can encourage wood destroying insect infestation. Back Side of Garage

Deteriorated Soffits and/or Facia

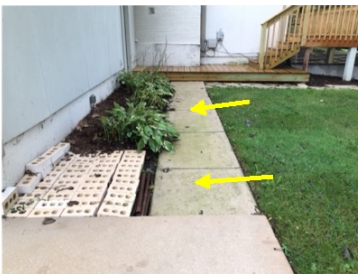
The back concrete walkway has settled toward the building which could allow storm water to accumulate along the foundation leaving the potential for water infiltration into the structure. Proper correction of settled walkway(s) by a qualified contractor is recommended.

Slight Settlement Towards Home

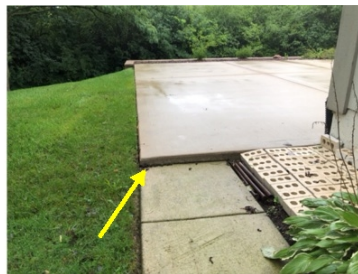
The back sidewalk had enough of a step to be considered a trip hazard. Correction is recommended for safety.

Trip Hazard(s)

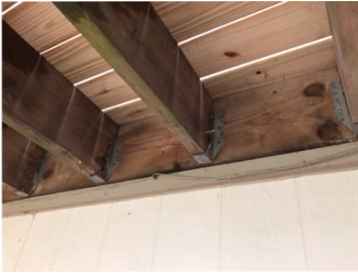
The ledger board for the deck appeared to be nailed to the house. The ledger board is an important structural component that should be properly attached to the main house (nails may allow it to pull away from the house) which could mean the use of special connector. Recommend further evaluation and correction by a qualified contractor.

Nailed Ledger

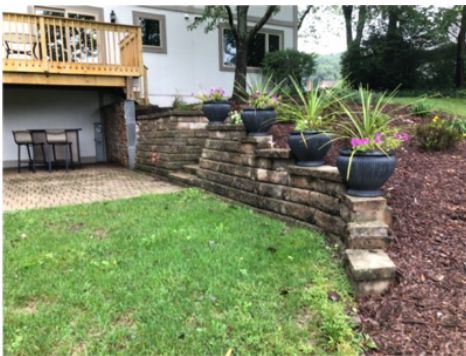
Possible structural movement was noted at and around the retaining wall(s). Further evaluation by a qualified contractor is recommended to determine what may be causing the movement and as to how repairs should be made.

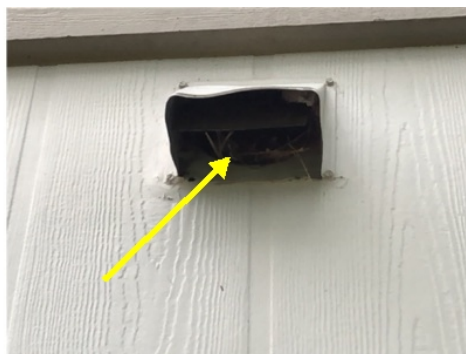
Visible clogging or debris was noted in the exterior portion of the bathroom vent. Professional cleaning is recommended. Clogged vents can be a fire hazard.

Bird Nesting (Bathroom Vent)

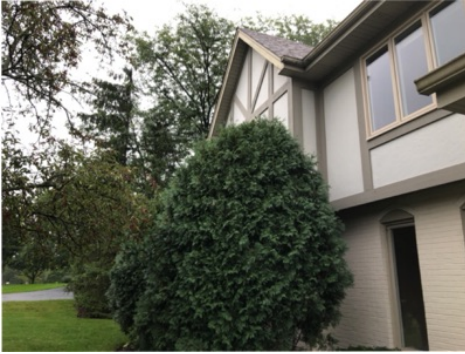
Recommend keeping trees, shrubs and/or vines cut back away from roof areas and the exterior of the building. At least 8 to 12 inches of clear space between the structure and any vegetation is recommended to promote proper air circulation and help prevent damage from moisture and insects.

Keep Trees Trimmed

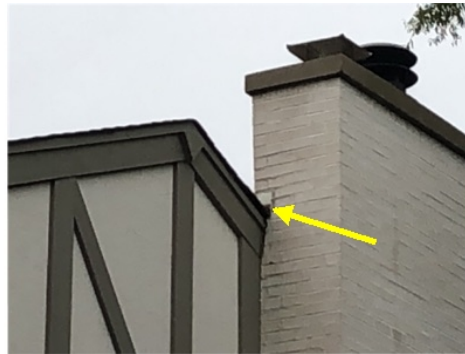
Open or damaged areas of flashing, with repair recommended, were noted: at the chimney(s)

Open Seam(s)

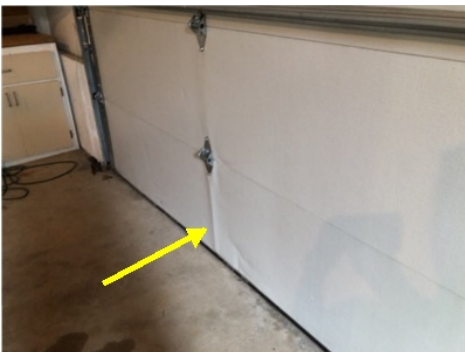
Denting and/or damage was noted on the garage door. The integrity of the door(s) has not been compromised in these areas and the door(s) will still function as intended.

Dented/Damaged Overhead Garage Door

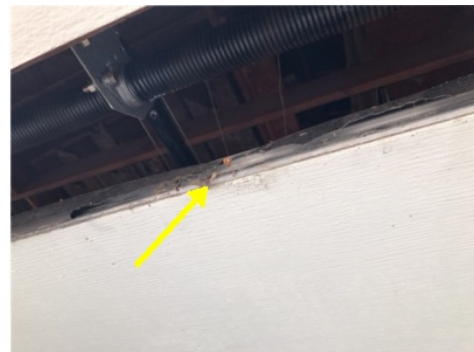
Recommend installing new exterior weather seals to the overhead garage door opening(s) to help keep the garage interior dry and draft free.

Damaged Weather Guard

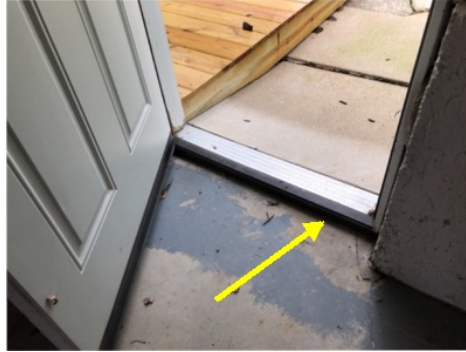
The door threshold was loose. Recommend adjustment and/or repair.

Loose Threshold

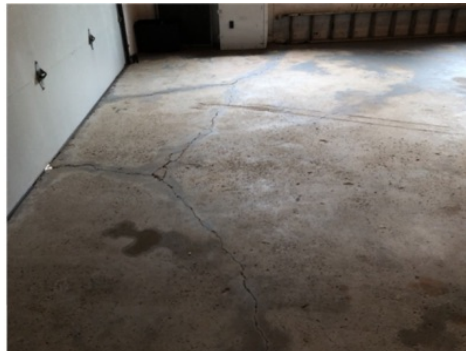
Some typical cracking of the floor was observed, which does not usually indicate a structural deficiency: monitoring of the cracking is recommended.

Typical Cracking

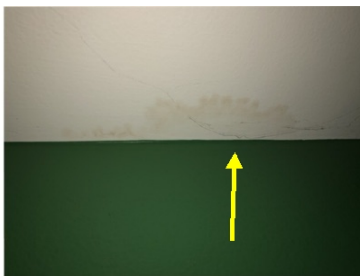
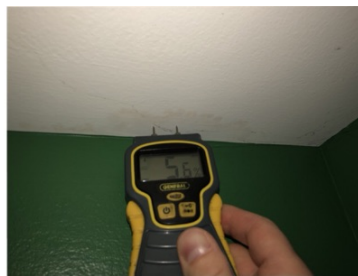
Staining (apparently from moisture) was observed on areas of the ceiling(s): The staining in these areas was DRY when tested with a moisture meter. Recommend monitoring of the staining and/or checking with the current owner. It is also recommended to determine and correct the source of the staining if still active. 2nd Floor Front Bedroom

Dry Staining (Front Bedroom)

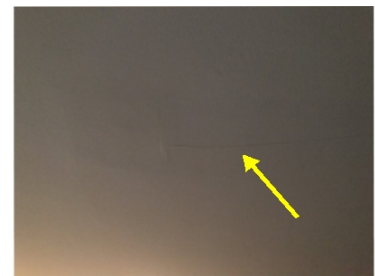
Cracks were observed that are common to drywall and plaster ceilings. These are usually cosmetic and may be repaired as desired however, monitoring of all cracking for possible movement is recommended. Some cracks will reoccur as a result of normal expansion and contraction from changing indoor humidity levels and seasonal changes.

Typical Cracking

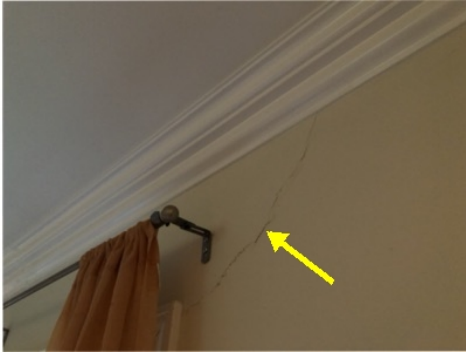
Typical Settlement Cracking

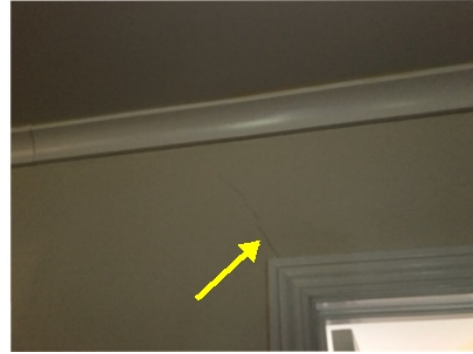
Typical Cracking

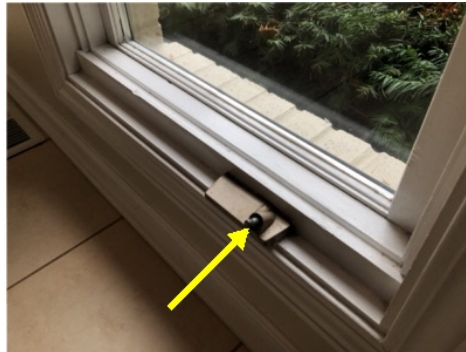
Some windows were found to be missing the operating cranks therefore, could not be opened or tested. Recommend checking with the current owner about the inventory of the cranks and testing the affected windows before the closing.

Missing Window Cranks

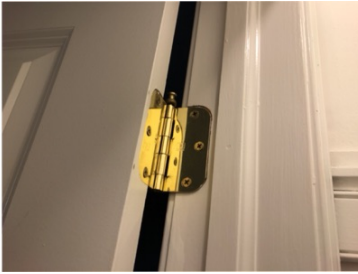
Loose Hinge(s)

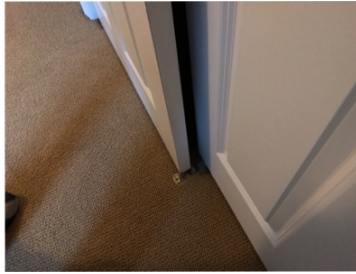
Misaligned Door Guide

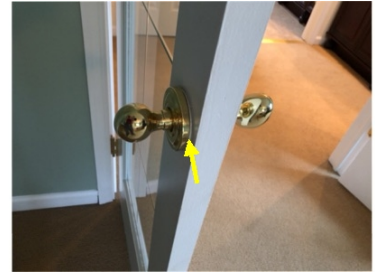
Loose Hardware

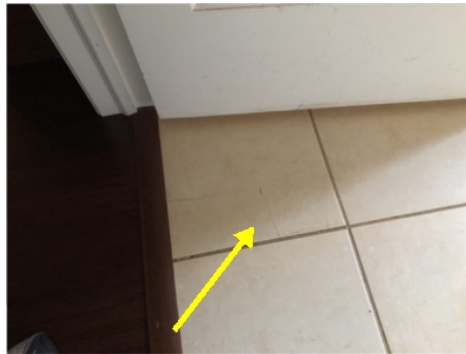
Cracked floor tiles were noted in some areas. This is usually a cosmetic issue caused by the sub-flooring being too flexible for tile. Correction may involve stiffening the sub-flooring to prevent new floor tiles from cracking.

Cracked Tile

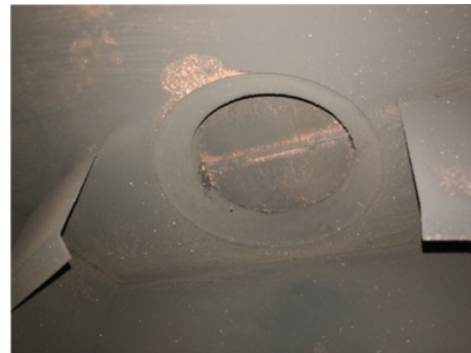
The flue damper(s) did not operate correctly. Recommend further evaluation and repair by a qualified contractor.

Damper Adjustment/Damage

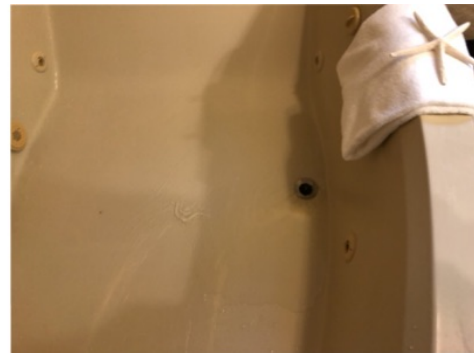
Missing Drain Stop

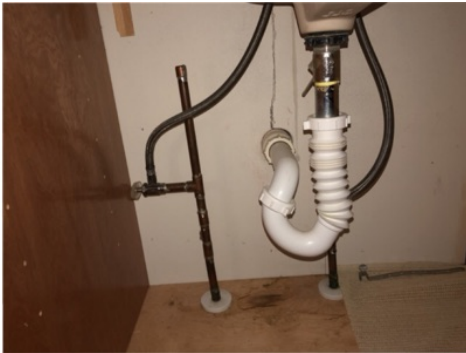
Page 28 Item: 7	Sink Drain	<p>The P-trap and/or or waste pipe under the sink was a ribbed (corrugated) non-listed type. This will tend to trap hair and scum and become clogged. Recommend replacement with a proper, smooth trap by a qualified plumber.</p> <p>The mechanical drain stopper was not functional or out of adjustment, correction is recommended.</p>
Page 28 Item: 9	Toilet	<p>The toilet fixture appeared to be loose at the floor. This condition can cause the toilet to leak at the base, potentially causing damaged and/or rotted flooring. Proper correction by a qualified contractor is recommended.</p> <p>A crack was observed in the toilet base. Replacement recommended by a qualified contractor if it is leaking, otherwise replace as desired.</p>

Ribbed Drain Pipe (Left Sink)

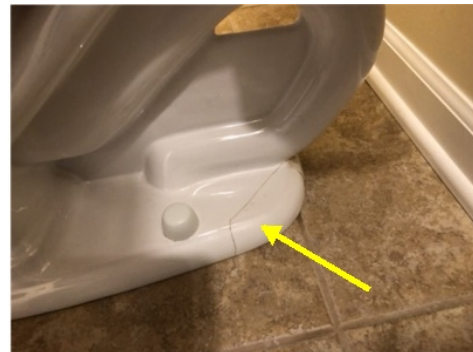
Cracked Toilet

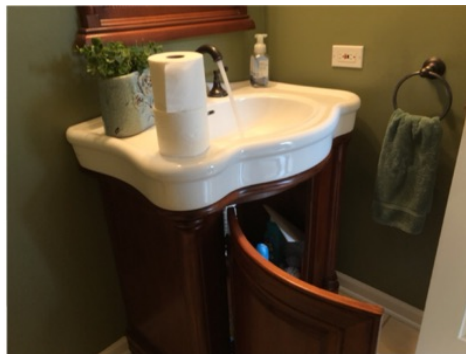
- The sink and/or vanity base cabinet was loose. Recommend properly attaching these tightly to the wall for safety and to prevent leaks from developing.

Loose Vanity

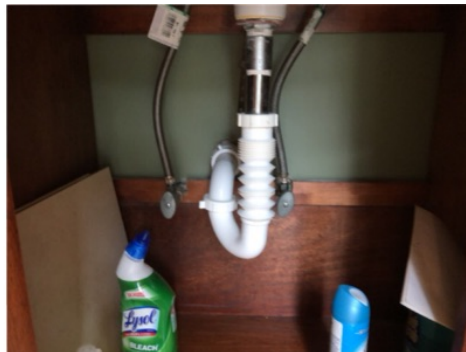
Page 30 Item: 3	Sink Drain	<ul style="list-style-type: none"> <li>The P-trap and/or or waste pipe under the sink was a ribbed (corrugated) non-listed type. This will tend to trap hair and scum and become clogged. Recommend replacement with a proper, smooth trap by a qualified plumber.</li> </ul>
--------------------	------------	---

- The P-trap and/or or waste pipe under the sink was a ribbed (corrugated) non-listed type. This will tend to trap hair and scum and become clogged. Recommend replacement with a proper, smooth trap by a qualified plumber.

Ribbed Drain Pipe

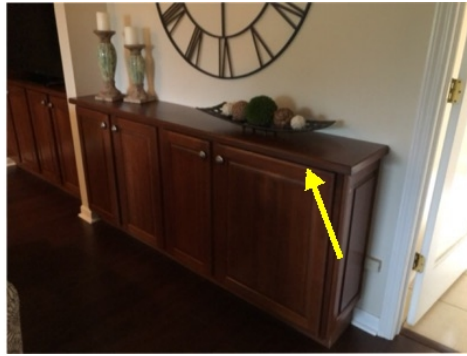
Loose Cabinet Top (Family Room)

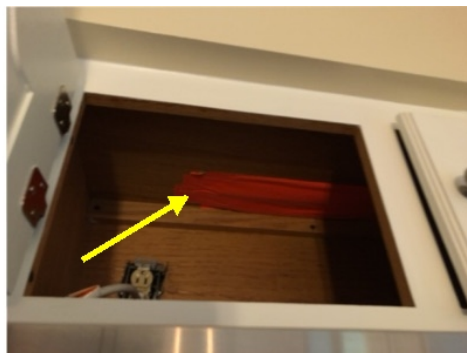
- Stove Top: System appears to recirculate to the interior.
- The hood filter was dirty at the time of the inspection. Recommend cleaning or replacement as desired.
- The old exhaust opening was sealed over with Duct Tape. This is a temporary fix.

Abandoned Exterior Exhaust

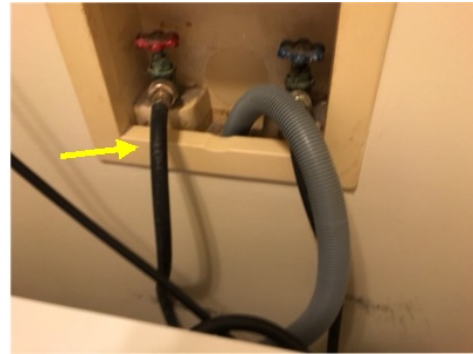
Hose Upgrade Recommended

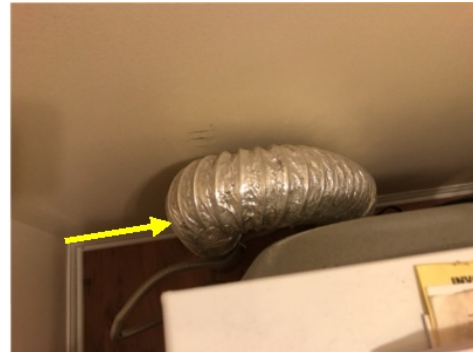
Improper Dryer Vent Material

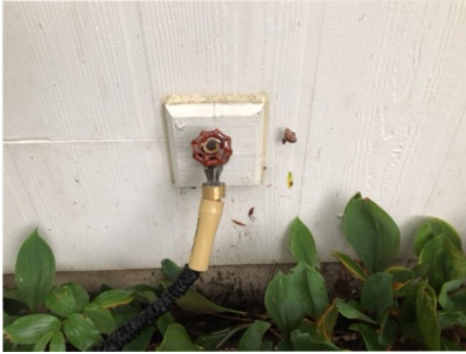
Non-Freeze Protected

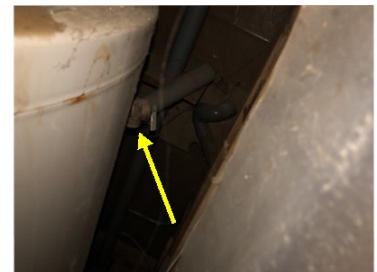
Page 41 Item: 1	Water Heater Comments	<p>The temperature and pressure relief valve was not properly piped. In an emergency, this valve will discharge scalding water. Recommend installing piping so that the valve will discharge to a point about 6 inches from the floor.</p> <p>The flue appeared to be backpitched (had negative rise or was dead level) which does not promote the proper passage of combustion products into the chimney. This could allow potentially hazardous flue gas and carbon monoxide to enter the building. Proper correction by a qualified heating or plumbing contractor is recommended.</p> <p>This equipment was near the end of or beyond its normal life expectancy. Budgeting for its eventual replacement is recommended.</p>
--------------------	--------------------------	--

Missing TPR Valve Extension

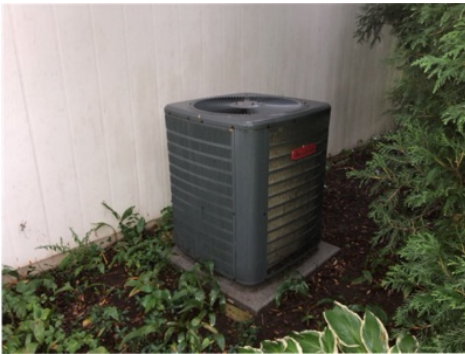
Page 45 Item: 1	Cooling Conditions	<p>The air conditioning equipment does not appear to have had recent maintenance. Heat exchanger defects may be hidden by dirt, debris or corrosion. Proper cleaning and further evaluation by a qualified heating contractor is recommended.</p>
--------------------	-----------------------	---

The air conditioning equipment does not appear to have had recent maintenance. Heat exchanger defects may be hidden by dirt, debris or corrosion. Proper cleaning and further evaluation by a qualified heating contractor is recommended.

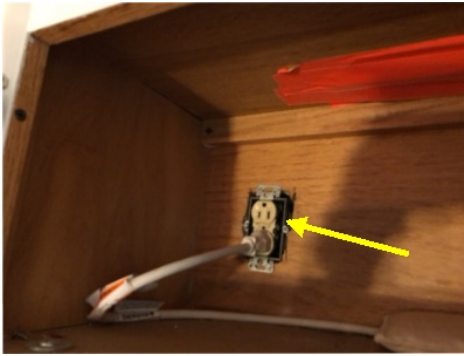
Missing Cover Plate

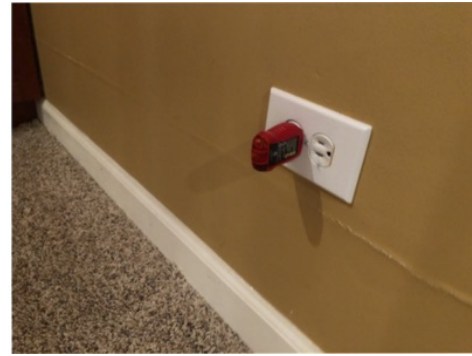
Page 46 Item: 3	Outlets	<p>One outlet at the bottom of the basement steps appeared to be non-functional when tested. The outlet(s) may be controlled by a wall switch that was not located, or may be dead for other reasons. Recommend checking with the current owner and/or further evaluation by a qualified electrician.</p>
--------------------	---------	---

Dead Outlet (Bottom of Basement Steps)

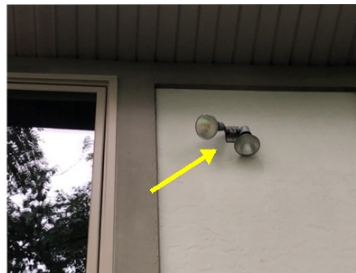
Page 47 Item: 4	Light Fixtures	<p>Multiple loose electrical/lighting fixture(s) were observed on the exterior (Soffits/Flood) which may be a safety hazard. Recommend proper repair or replacement by a qualified electrician.</p> <p>One electrical/lighting fixture in the hallway to the garage did not operate at the time of the inspection using normal controls. This often indicates that light bulbs may be burned out. Recommend checking with the current owner and verifying operation before the closing.</p>
Page 48 Item: 5	Ground Fault Circuit Interrupters	The Ground Fault Circuit Interrupter (GFCI) outlet did not turn off when the test buttons were operated. These devices reduce the risk of electrocution in wet areas. Recommend replacement of all defective GFCI outlets by a qualified electrician to restore protection. These were identified as being deficient in the: Master Bathroom and Exterior at the Deck.

Loose/Damaged Flood Light (Back)

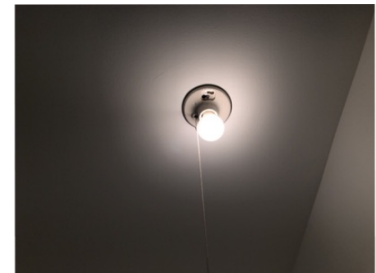
Exposed Closet Bulbs

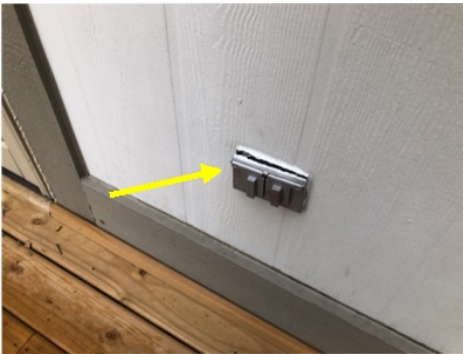
Loose/Damaged GFCI

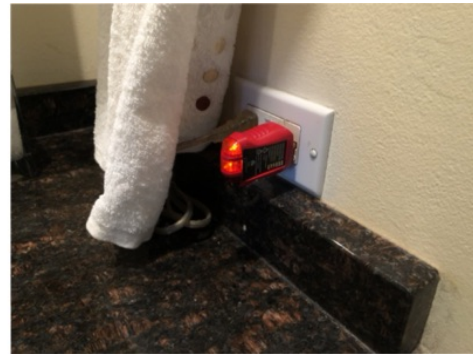
The Ground Fault Circuit Interrupter (GFCI) outlet did not turn off when the test buttons were operated. These devices reduce the risk of electrocution in wet areas. Recommend replacement of all defective GFCI outlets by a qualified electrician to restore protection. These were identified as being deficient in the: Master Bathroom and Exterior at the Deck.

Failed GFCI (Master Bath)

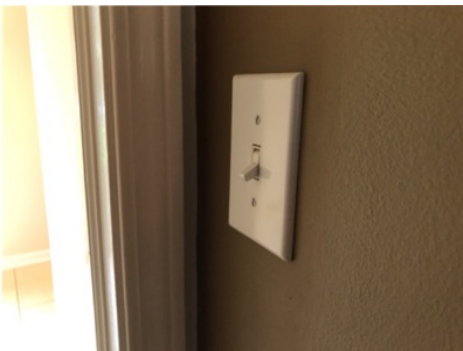
Two loose switches were noted, one in the dining room and one in the family room. These may be difficult to operate and may also present a shock hazard. Recommend all switches be properly secured by a qualified electrician.

Loose/Worn Switch (Family Room)

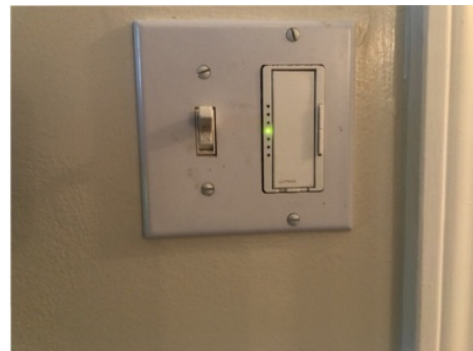
Loose/Worn Switch (Dining Room)

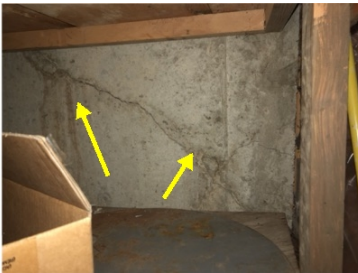
Page 52 Item: 8	Foundation Walls	<ul style="list-style-type: none"> <li>• Staining (apparently from moisture), was observed on areas of the foundation walls which was DRY when tested with a moisture meter. Recommend monitoring of the staining and/or checking with the current owner for further information. Also recommend determination and correction of the source of the staining if still active.</li> <li>• Areas of possible structural movement of the foundation wall(s) were noted. Further evaluation by a licensed structural engineer and/or a qualified contractor is recommended.</li> </ul>
--------------------	------------------	---

Moisture Staining (Dry)

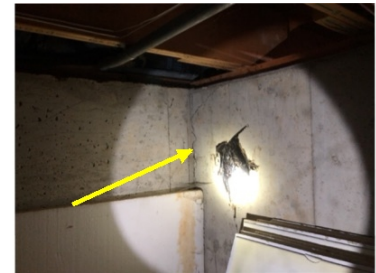
- Cracks were observed that are common to this type of construction. These are usually cosmetic and may be repaired as desired, however monitoring of all cracking for possible seepage or movement is recommended.
- Staining (apparently from moisture), was observed on areas of the foundation walls which was DRY when tested with a moisture meter. Recommend monitoring of the staining and/or checking with the current owner for further information. Also recommend determination and correction of the source of the staining if still active.
- Areas of possible structural movement of the foundation wall(s) were noted. Further evaluation by a licensed structural engineer and/or a qualified contractor is recommended.

Possible Structural Movement

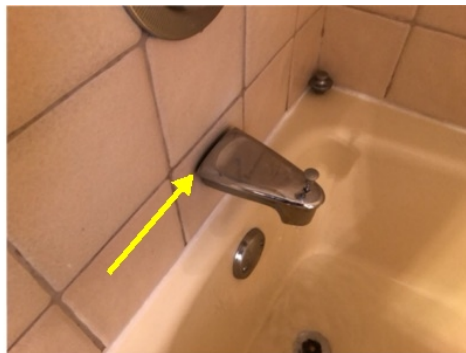
There is a gap between the tub spout and the wall surround. This location is an excellent area for water to entry the wall cavity. Sealant is recommended in this area.

Gap at the Faucet

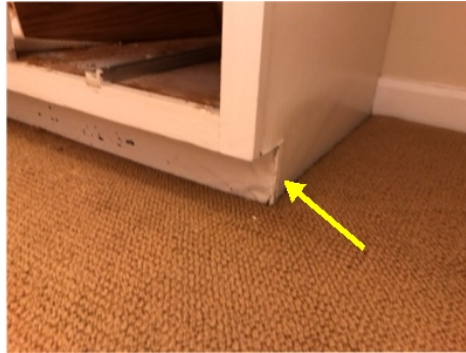
Staining was observed under the sink. The staining was DRY when tested with a moisture meter. Recommend monitoring of the staining and/or checking with the current owner. It is also recommended to determine and correct the source of the staining if still active.

Water Damaged Vanity

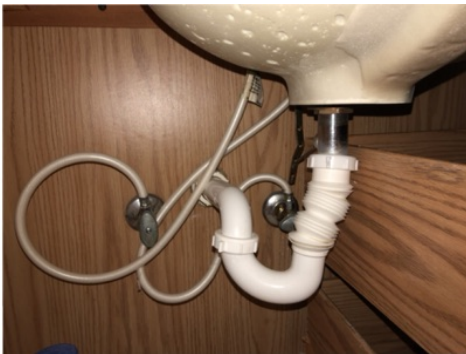
Page 54 Item: 7	Sink Drain	<p>The P-trap and/or or waste pipe under the right sink was a ribbed (corrugated) non-listed type. This will tend to trap hair and scum and become clogged. Recommend replacement with a proper, smooth trap by a qualified plumber.</p> <p>Leaking was noted under the right sink from the waste line and/or other piping. Correction by a qualified plumber is recommended.</p> <p>The mechanical drain stopper at both sinks was not functional or out of adjustment, correction is recommended.</p>
--------------------	------------	---

Leaking/Flex Drain (Right)
