*The BrickKicker is pleased to present this
professional home inspection report
for the property located at:*

**1137 N Connor Trail
Sioux Falls, SD 57103**

inspected on 07/30/2015

Property Inspection Report

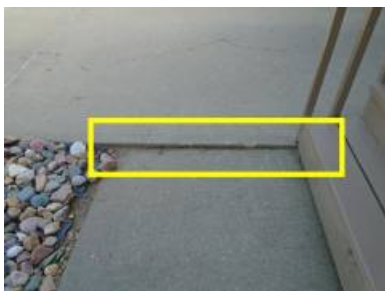
Concrete Walkway(s):

The building's walk(s) have some uneven sections with trip ledges which would benefit with feathering and/or additional types of repair or replacement for pedestrian safety.

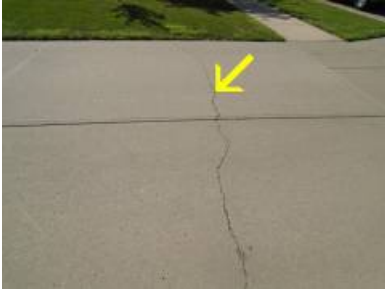
Concrete driveway:

Typical cracking was noted. This is usually caused by shrinkage of the concrete as well as compaction of the soil under the driveway over time, and usually occurs only in the first few years after the driveway is installed. Monitoring of the cracking is recommended.

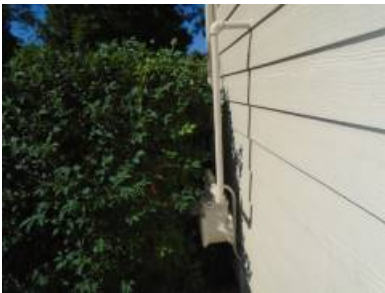
J. Vegetation (Trees, shrubs, vines affecting the building)

Recommend keeping trees, shrubs and/or vines cut back away from roof areas and exterior of building. At least 8 to 12 inches of clear space between the structure and any vegetation is recommended to promote proper air circulation and help prevent damage from moisture and insects.

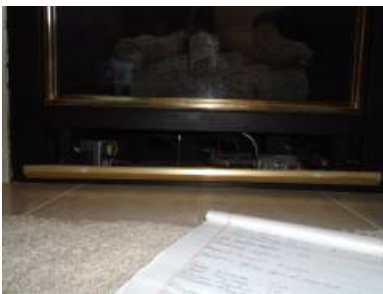
Fireplace(s): Gas.

If Fireplaces or Solid Fuel Burning Stoves were present, only visible and readily accessible portions of the fireplaces or stoves have been reviewed.

Flue defects may exist that can only be discovered through a Level 2 chimney inspection performed by a qualified chimney sweep.

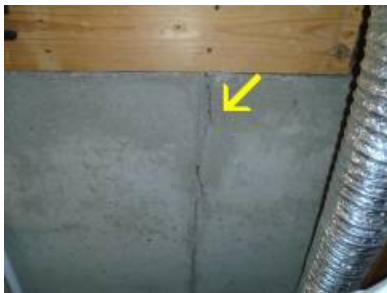
F. Foundation Walls

Typical settlement cracks were observed at one or more areas. They commonly occur in the first few years after the building is completed and do not usually indicate a structural deficiency. Monitoring of the cracking is suggested. If the cracking appears to increase in size or area, then additional review is recommended.

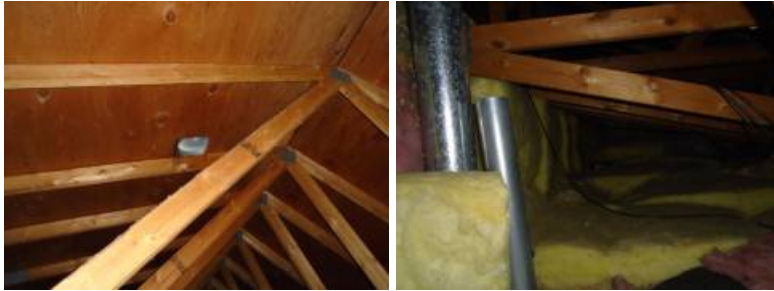
Access / Visibility Access and visibility of the attic spaces were typical. Attic areas were not fully accessible for observation. Attic space(s) not walked due to blown-in insulation.
