*The BrickKicker is pleased to present this
professional home inspection report
for the property located at:*

**XXXXXXX
XXXXXXX, TN 3XXXX**

September 23, 2016

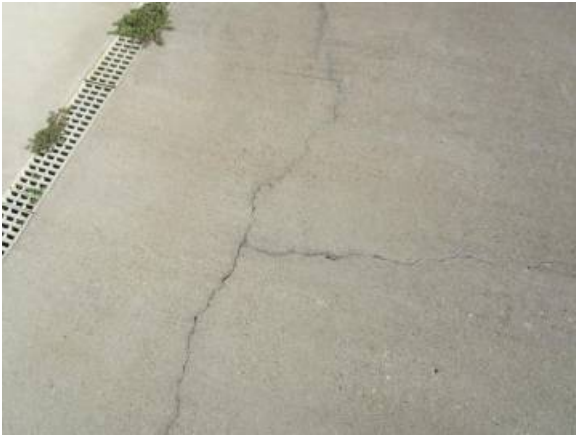
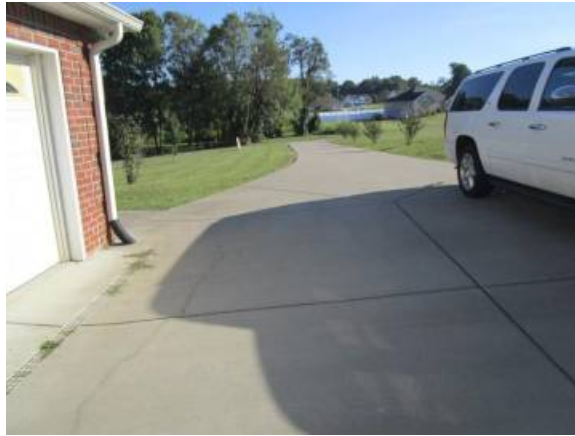
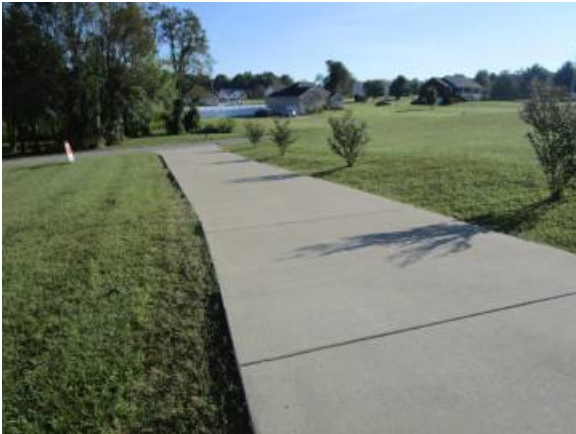
Concrete driveway:

Typical cracking was noted. This is usually caused by shrinkage of the concrete as well as compaction of the soil under the driveway over time, and usually occurs only in the first few years after the driveway is installed. Monitoring of the cracking is recommended.

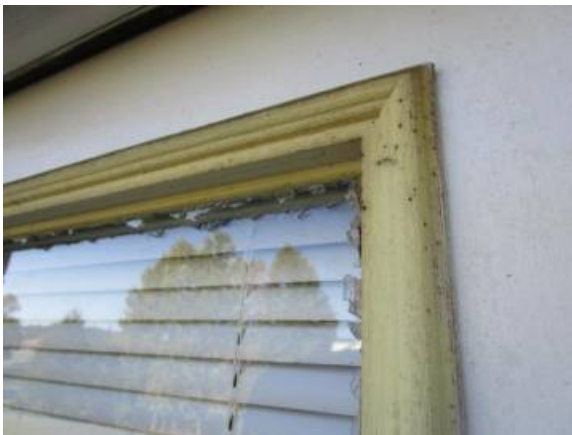
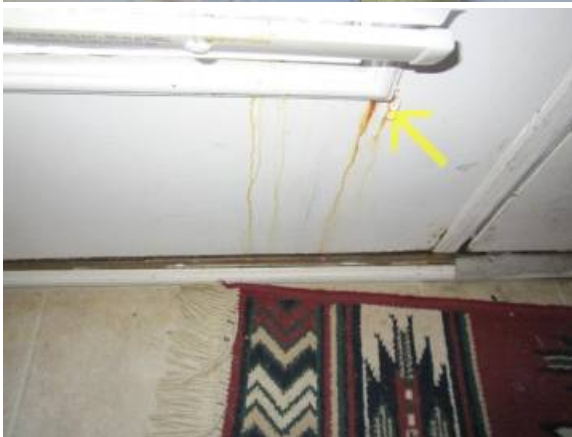
EXTERIOR DOOR(S)

Panes of glass in the basement exterior doors were noted to be broken. Proper replacement of the broken glass is recommended for safety and security.

The side jambs of the basement exterior doors were rotted. Proper repair and refinishing is recommended.

The basement exterior door appeared to leak water during a rain storm. Recommend further evaluation and correction by a qualified contractor.

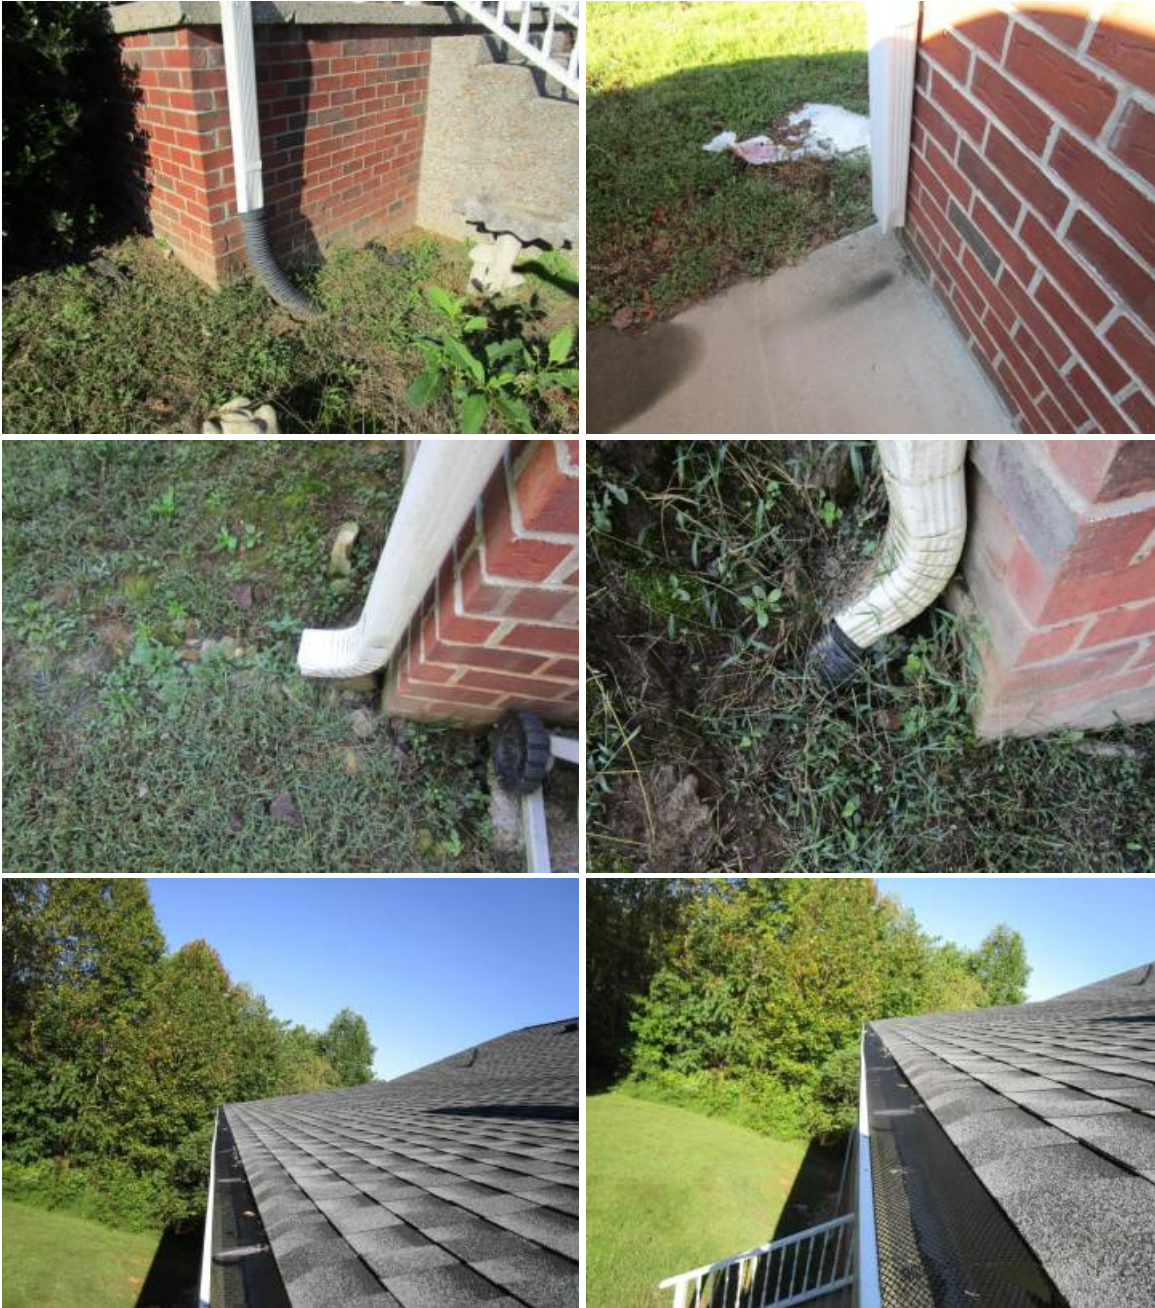
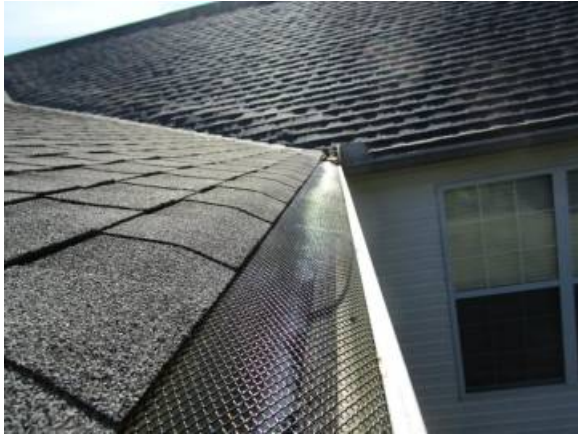
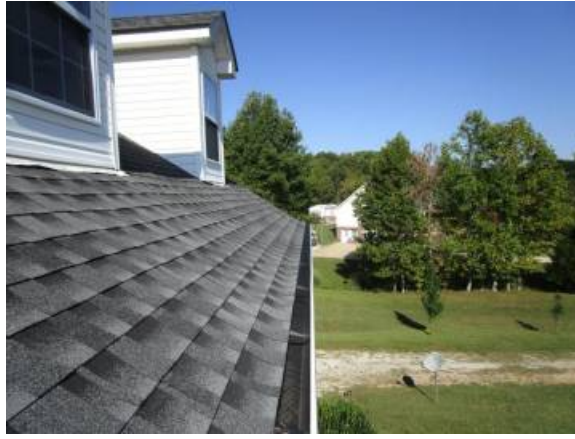
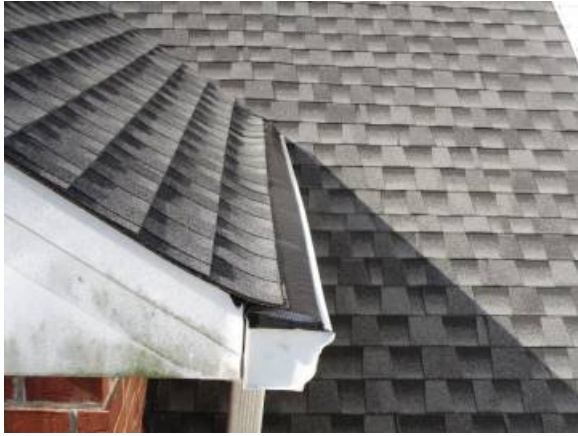
GUTTERS & DOWNSPOUTS

A downspout on the front right of the house appeared to be loose from the black corrugated drain pipe. Recommend re-attaching the downspout to the drain pipe.

Recommend all downspout drainage be directed at least 5 feet away from the foundation areas. Keeping water away from the foundation is beneficial for keeping areas such as crawl spaces and basements dry.

Some of the downspouts drain into an underground system. We are unable, as a part of this inspection, to determine where they drain to and if they are functional.

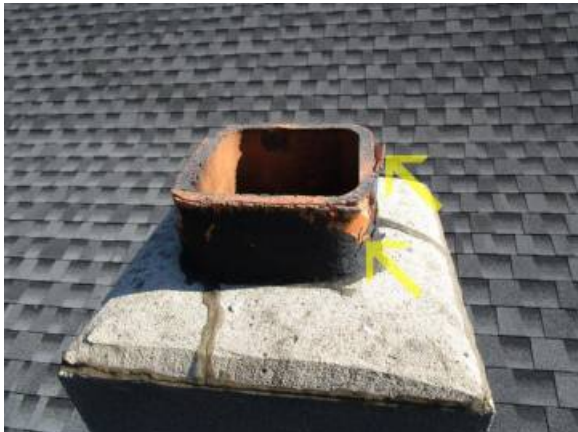
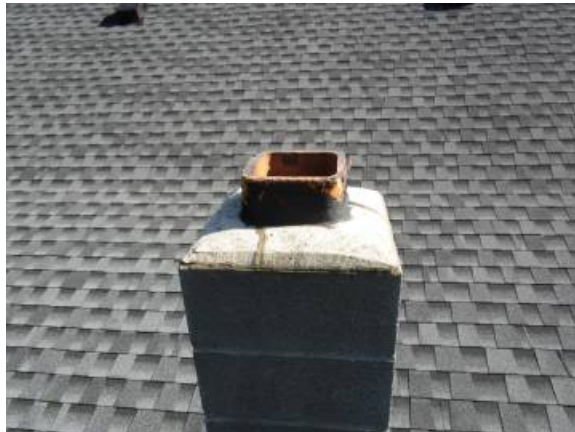
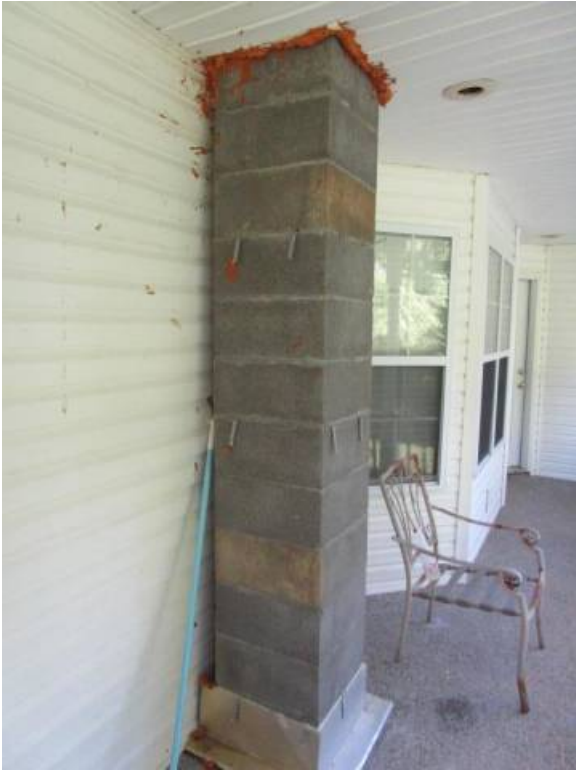
CHIMNEY(S) & CAP(S)

The clay tile flue appeared to be cracked or otherwise damaged when observed from the top of the chimney, which is a potentially hazardous condition. Further evaluation by a qualified contractor is recommended.

A Spark Arrestor or rain cap was not in place on the masonry chimney. The installation of one will greatly reduce the opportunity for rain water to directly enter the chimney liner.

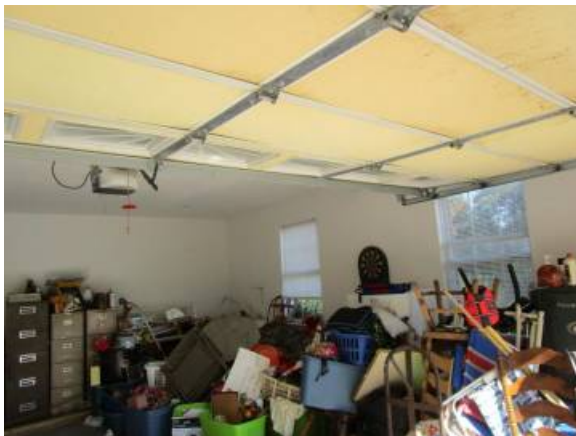
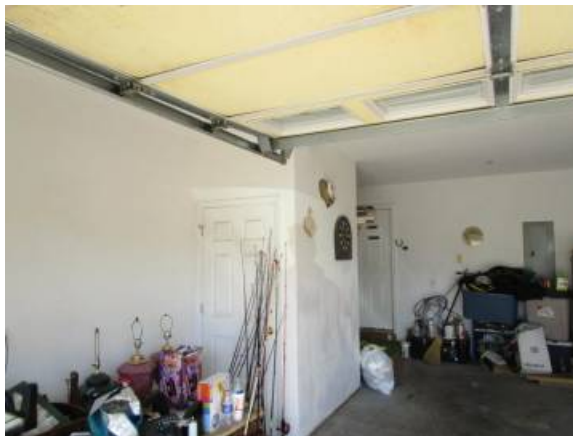
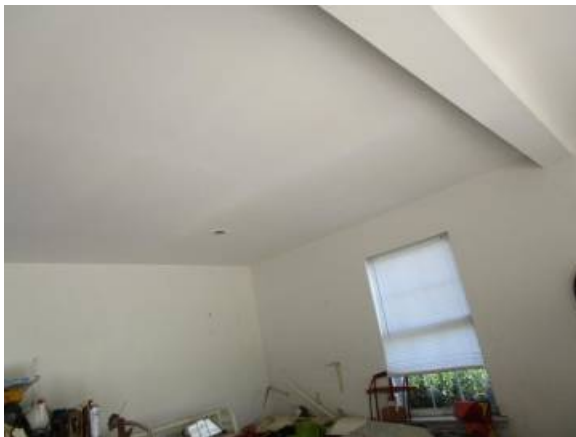
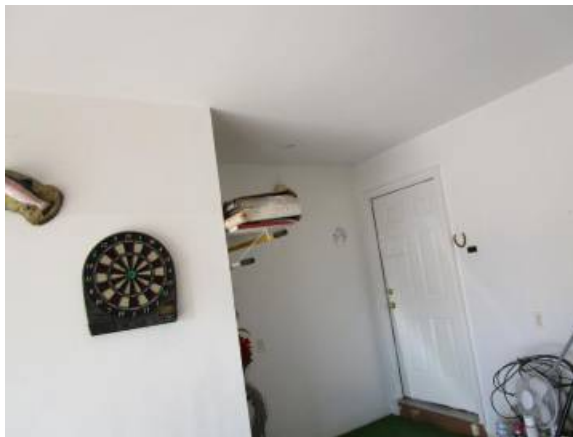
GARAGE INTERIOR

Portions of the garage interior were not inspected due to stored personal items blocking access. Stains or defects may be hidden behind these items and are excluded from this inspection. Recommend a careful review of these areas after the stored items have been removed.

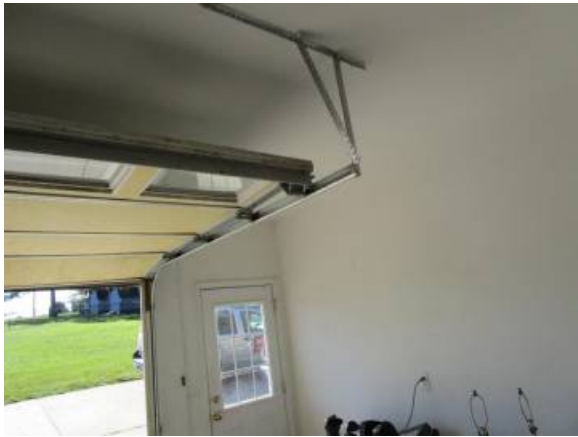
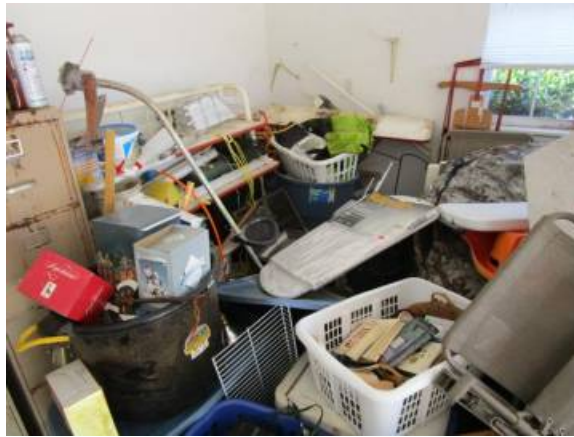
AUTOMOTIVE DOOR(S)

The bottom of the door was rusted. Proper repair and refinishing is recommended to extend the life of the garage door.

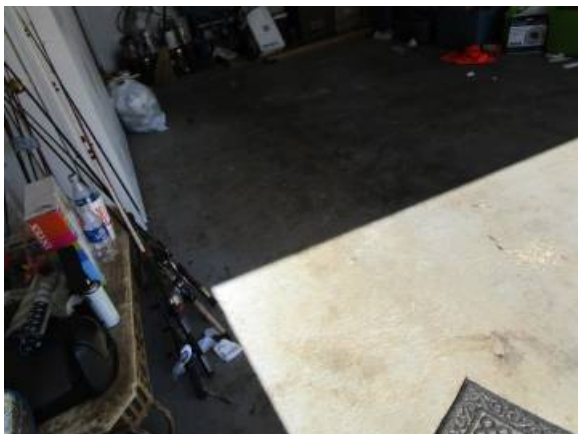
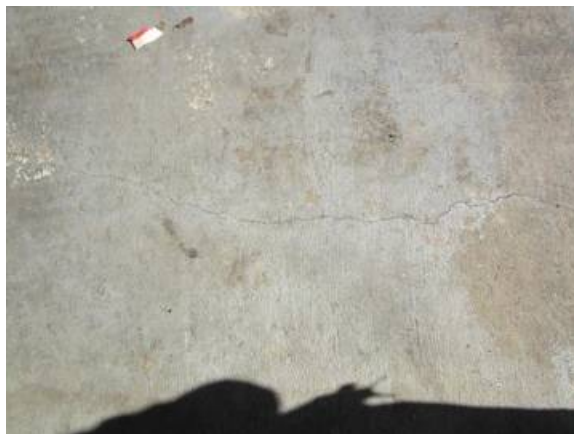
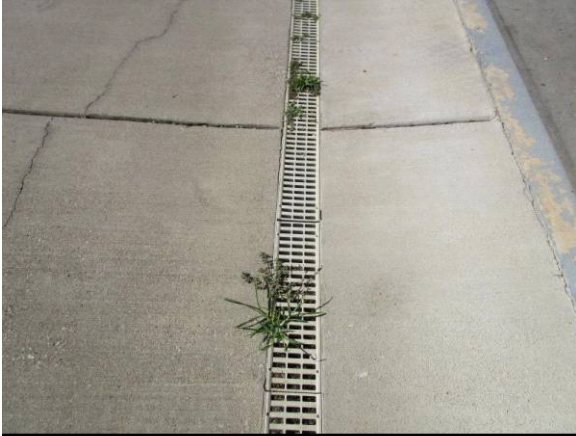
Drain Full of Debris

The drain outside of the garage door appeared to be completely filled with debris. This likely contributes to the water intrusion that caused the water stains on the garage floor. Recommend cleaning the drain.

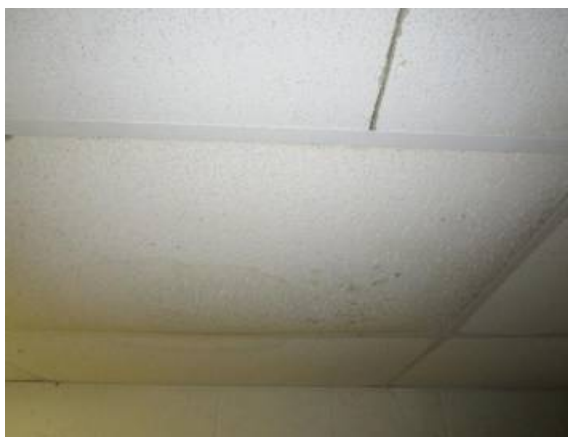
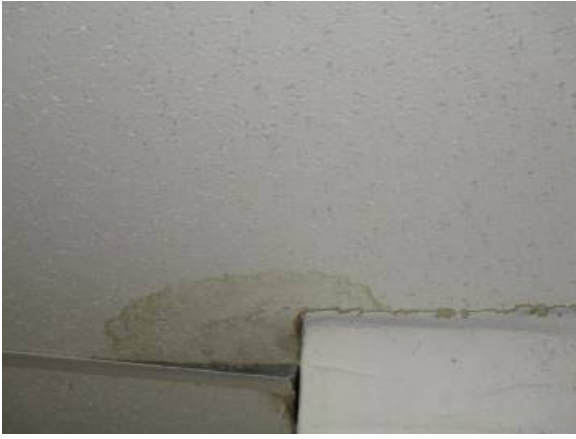
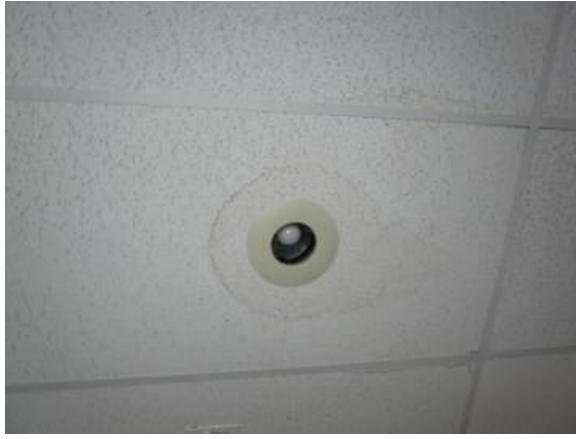
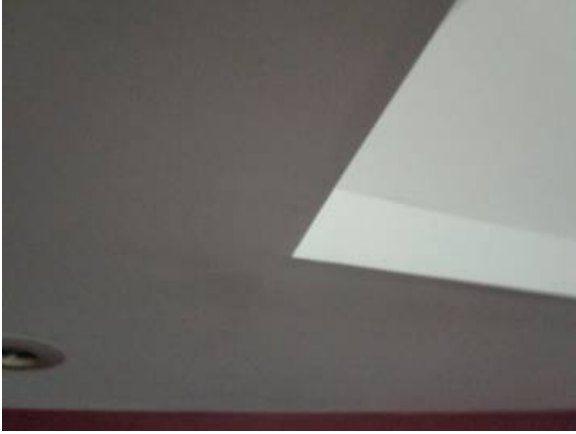
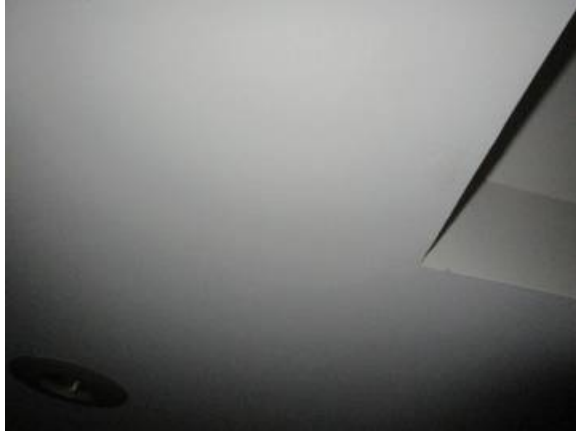
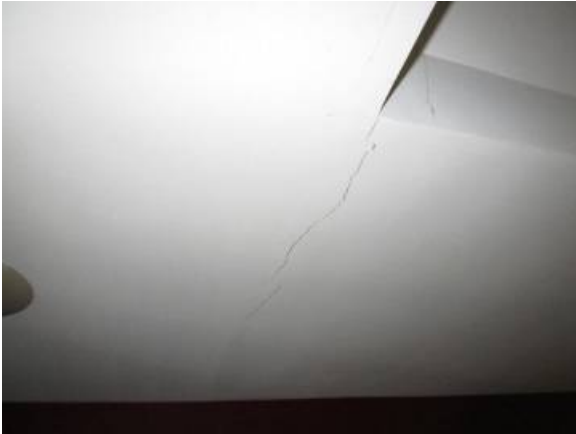
Staining (apparently from moisture) was observed in numerous areas of the basement ceiling: The staining was DRY at one or more areas when tested with a moisture meter. Recommend monitoring of the staining and/or checking with the current owner. It is also recommended to determine and correct the source of the staining if still active.

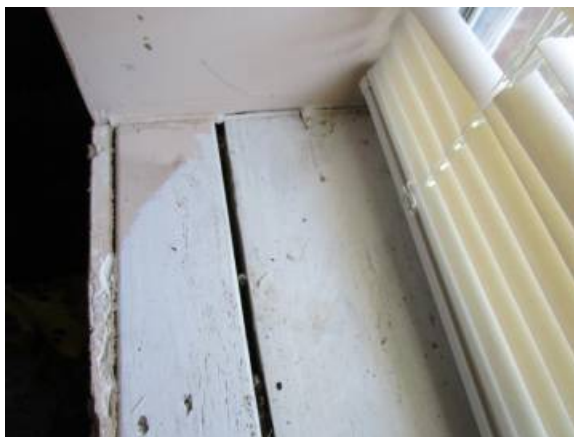
The window sill in the basement bedroom appeared to be unfinished. There was a large gap running the length of the sill.

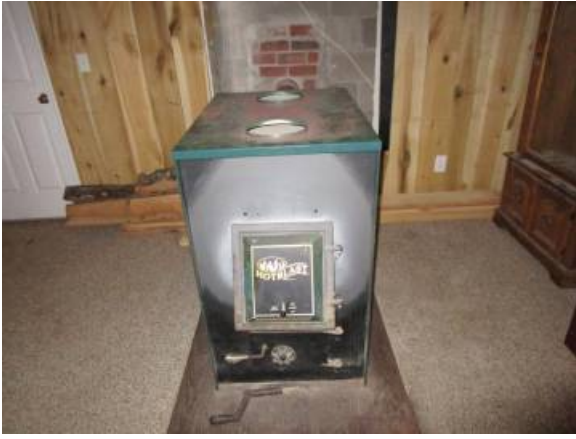
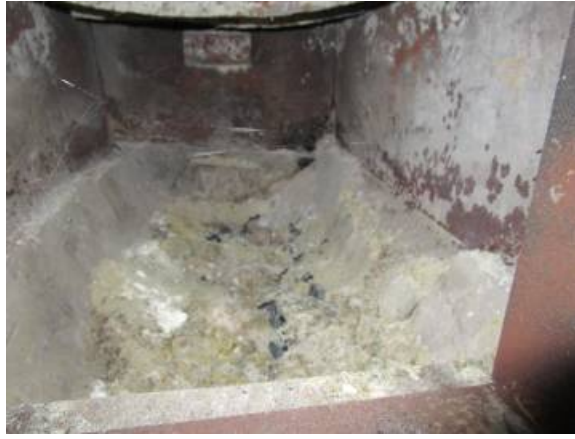
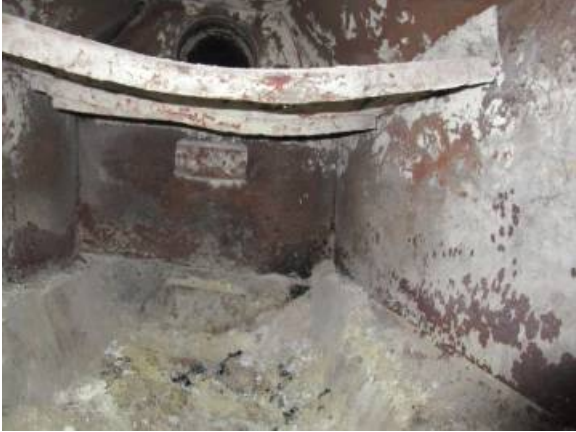
FIREPLACE(S) / SOLID FUEL BURNING STOVE(S)

Wood (Solid Fuel) Burning Stove(s): The wood burning stove in the basement was full of ashes and/or debris. Defects may be hidden under and behind this material. Recommend proper cleaning and further evaluation of the stove by a qualified chimney sweep.

Due to the design of the wood burning stove, the interior of the flue could not be observed. Hidden defects may exist in the flue.

Recommend further review of the chimney and proper cleaning of the flu by a certified chimney sweep.

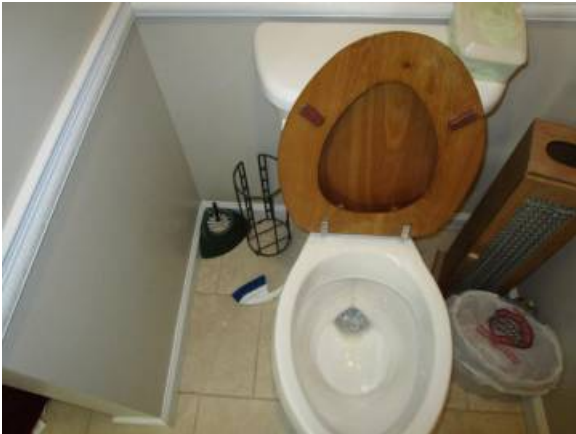
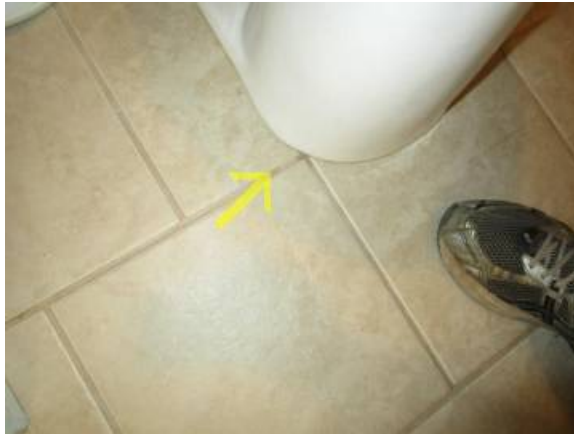
FLOOR

One or more cracked floor tiles were noted. This is usually a cosmetic issue caused by the sub-flooring being too flexible for tile. Correction may involve stiffening the sub-flooring to prevent new floor tiles from cracking.

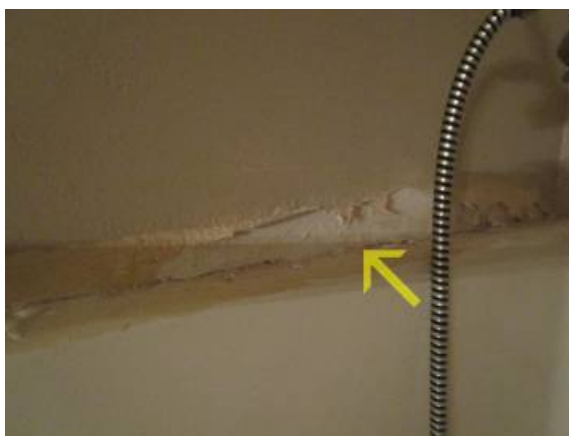
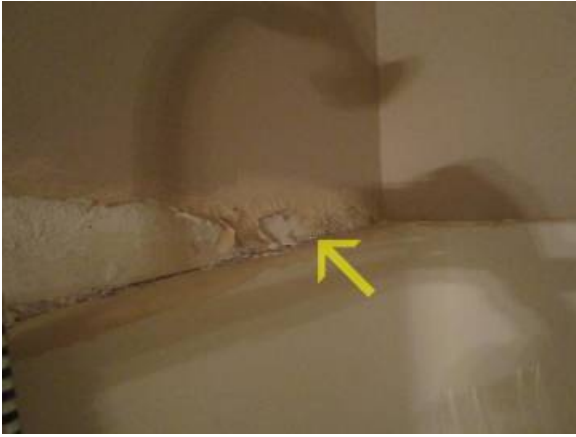
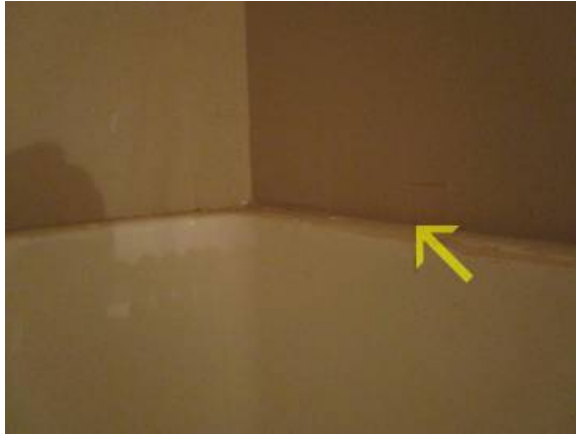
SHOWER (Includes Wall/Tile)

Staining (apparently from moisture) was observed around the top of the shower wall: The staining was DAMP or WET at one or more areas when tested with a moisture meter. This indicates the probable presence of one or more leaks: recommend that the source of the moisture be determined and corrected by a qualified contractor.

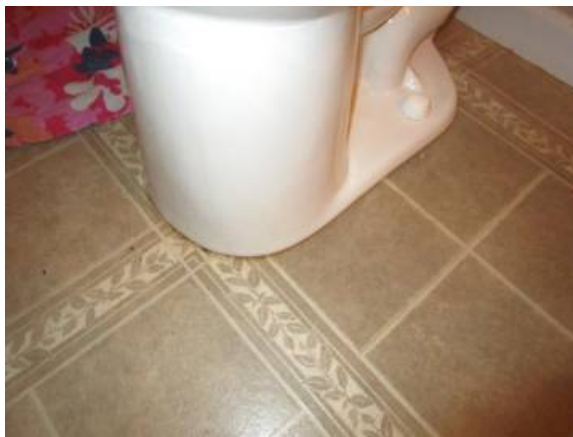
TOILET

The flooring at the base of the toilet was wet when tested and the toilet appeared to be leaking at the base (will probably need a new wax seal). Correction by a licensed plumber is recommended.

The toilet fixture appeared to be loose at the floor. This condition can cause the toilet to leak at the base, potentially causing damaged and/or rotted flooring. Proper correction by a qualified contractor is recommended.

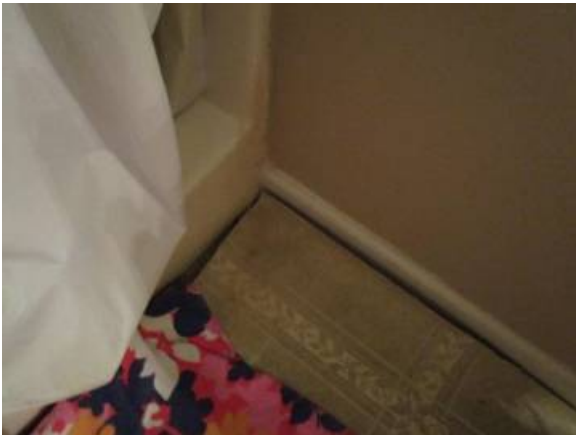
FLOOR

The vinyl sheet flooring was observed to be lifted at edges and/or seams in one or more locations. Proper repair is recommended.

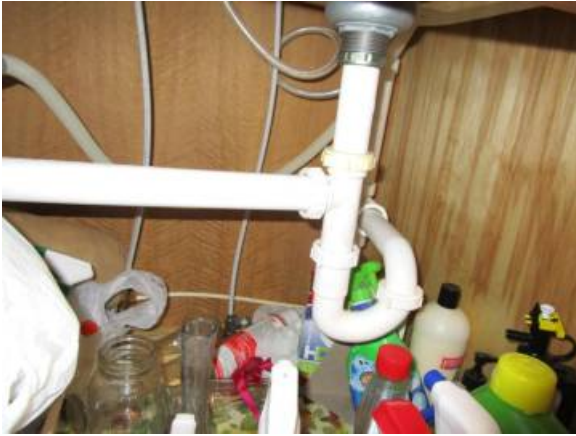
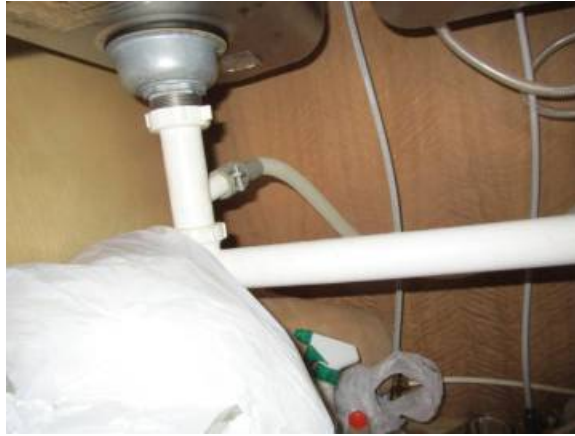
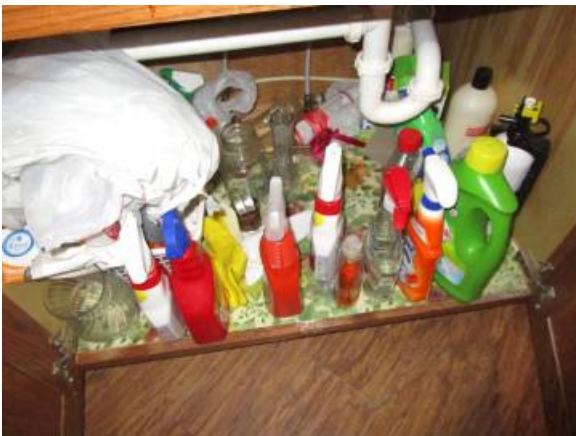
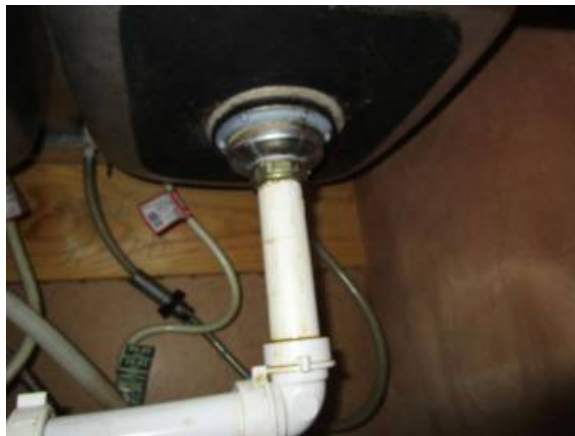
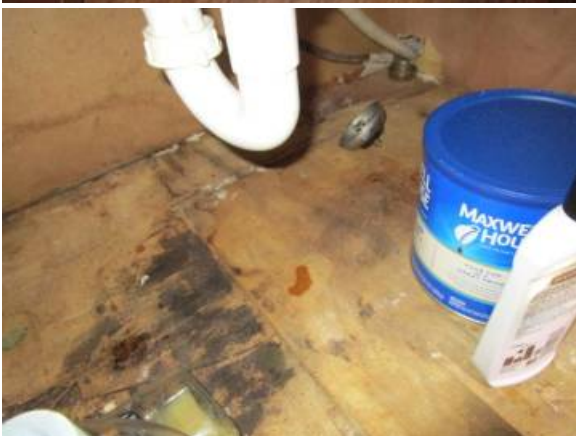
SINK DRAIN

The drain/waste piping below sink was not fully visible because of stored personal items. Defects may be hidden behind by the stored items: careful review of this area during the final walk-through is suggested.

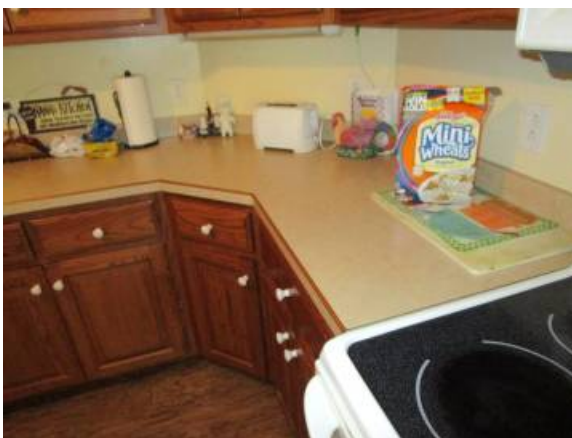
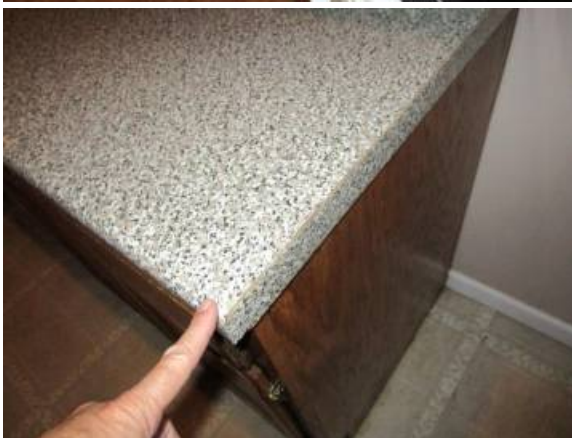
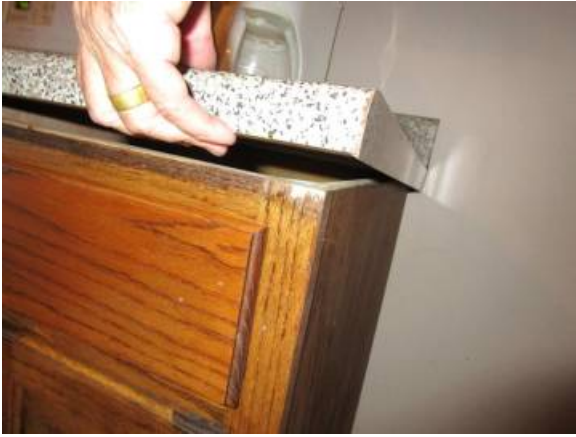
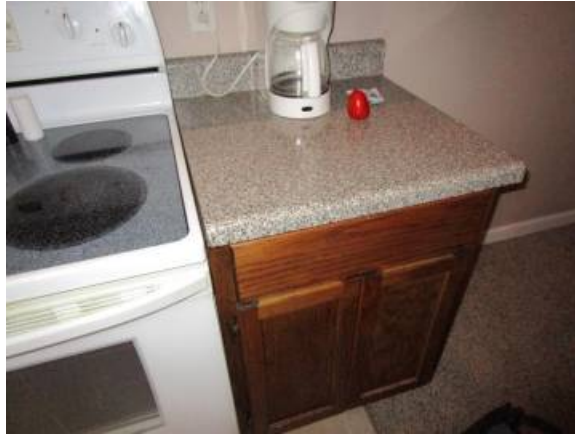
COUNTERTOP(S)

The countertop(s) were loose at one or more locations in the basement kitchen. Recommend properly securing all countertops to the base cabinets.

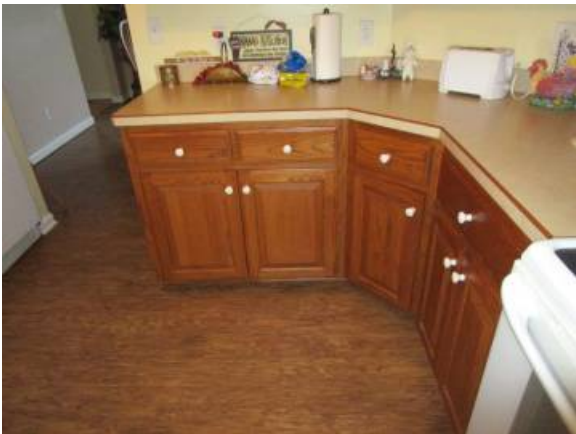
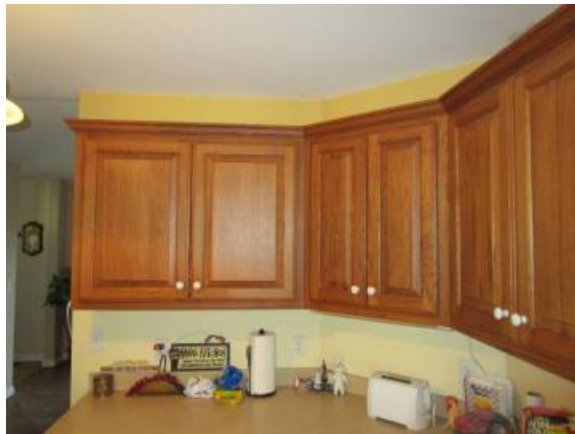
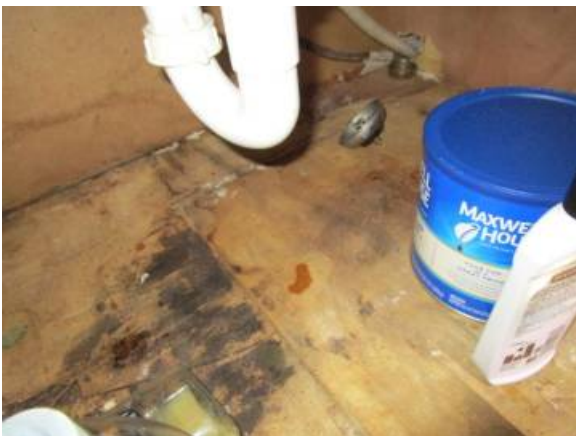
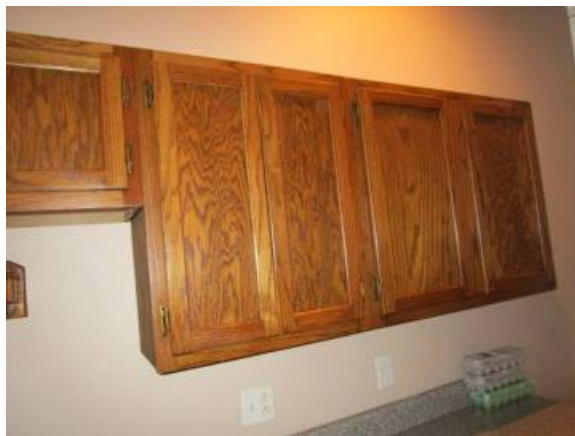
CABINETS (Sample Testing Only)

Staining was observed under the sink in the basement kitchen: The staining was DRY when tested with a moisture meter. Recommend monitoring of the staining and/or checking with the current owner. It is also recommended to determine and correct the source of the staining if still active.

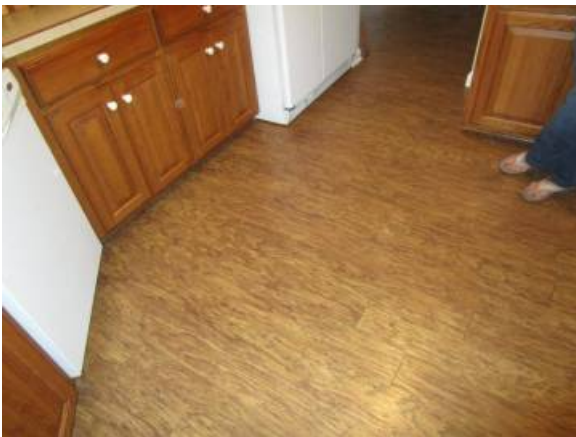
FLOOR

Loose flooring was observed in one or more areas first floor kitchen. This may be a tripping hazard, and proper repair is recommended.

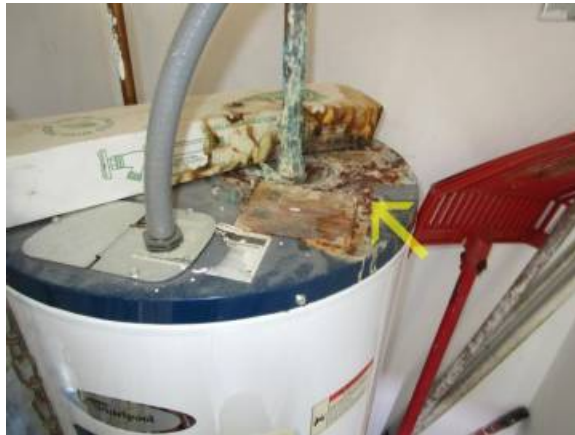
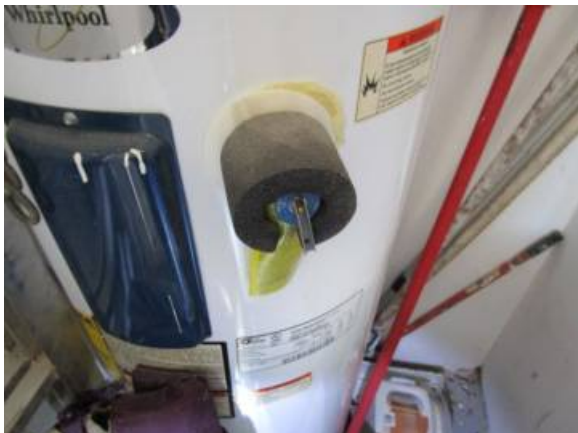
Active water drips and/or leaks were observed above the water heater. Proper repair by a licensed plumber is recommended.

Rust or corrosion was noted at the top of the water heater. This is usually caused by leaking supply pipes. Recommend correction of the leaks, if still present, and monitoring of the water heater for continued function and performance.

The temperature and pressure relief valve was not properly piped. In an emergency, this valve will discharge scalding water. Recommend installing piping so that the valve will discharge to a point about 6 inches from the floor.

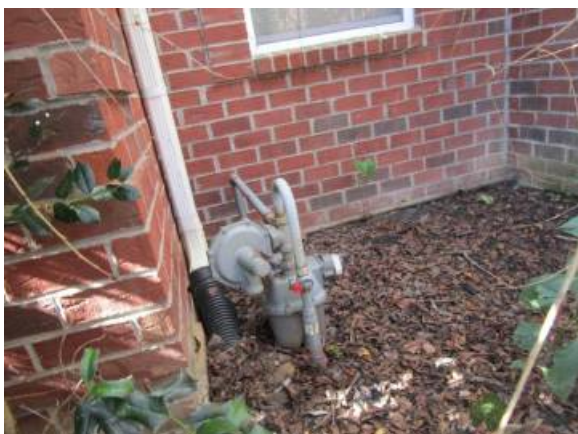
FUEL SUPPLY PIPING & STORAGE

The gas was shut off at the meter. Therefore, the gas piping could not be fully inspected or checked for leaks, and gas-fired appliances and equipment in the house and/or garage could not be checked for operation. Recommend checking with the current owner and inspection of the gas piping, appliances and equipment after the gas is turned on and before the closing.

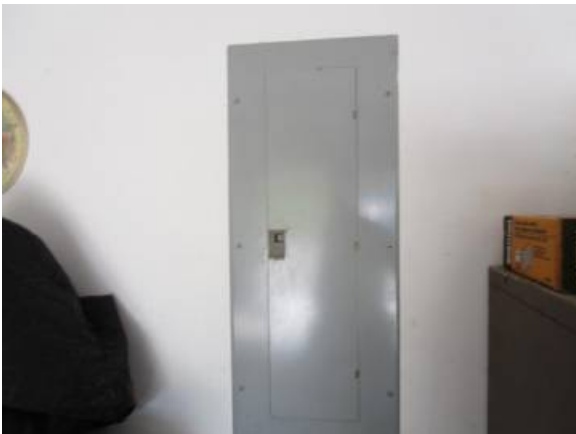
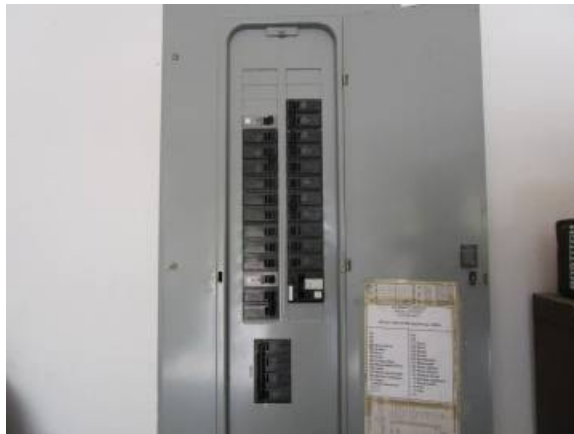
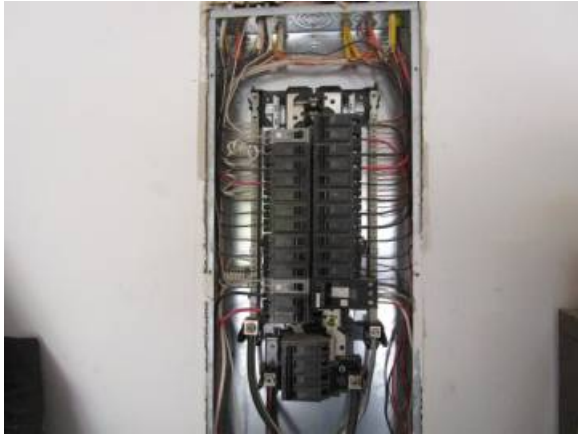
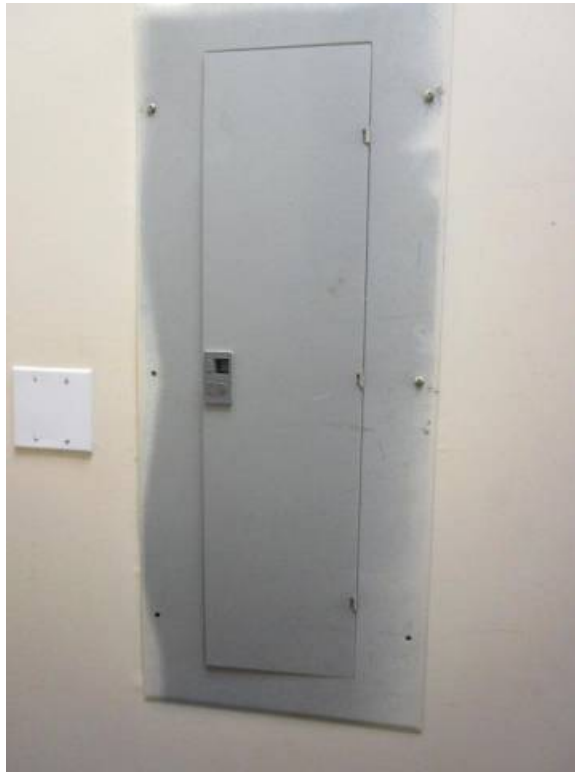
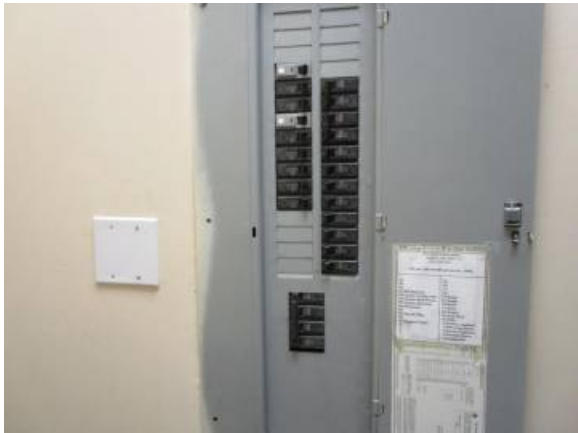
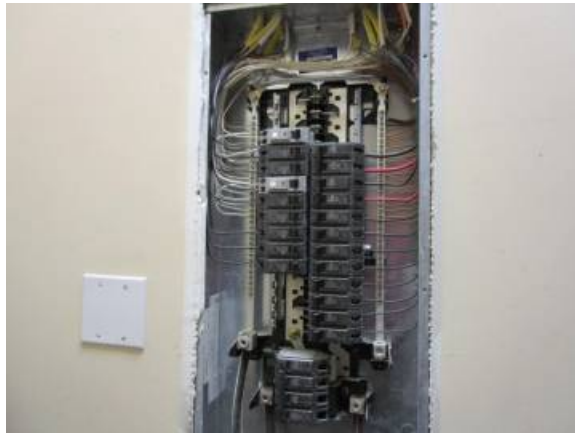
SUB PANEL(S)

Electrical Panel and Cabinet: One or more bushings were noted to be missing in the garage panel . Proper correction by a qualified electrician is recommended to prevent possible damage to the wiring.

Electrical Panel and Cabinet: The electrical panel cover in the basement was missing one or more of the attachment screws. If multiple screws are missing, this is a potentially hazardous situation. Recommend replacing all missing screws with properly fitting blunt end (not pointed) screws.

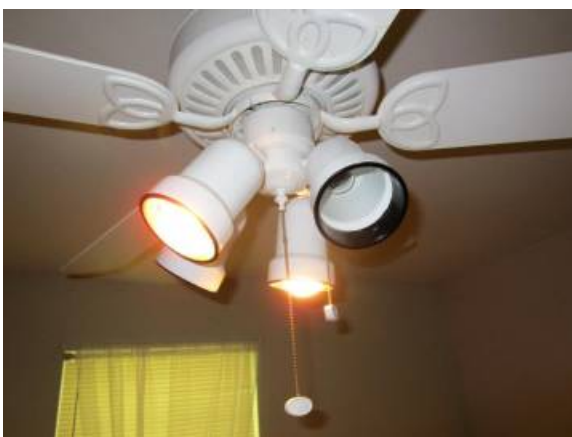
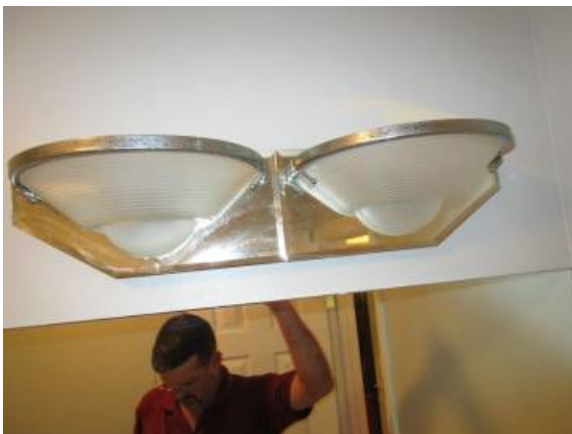
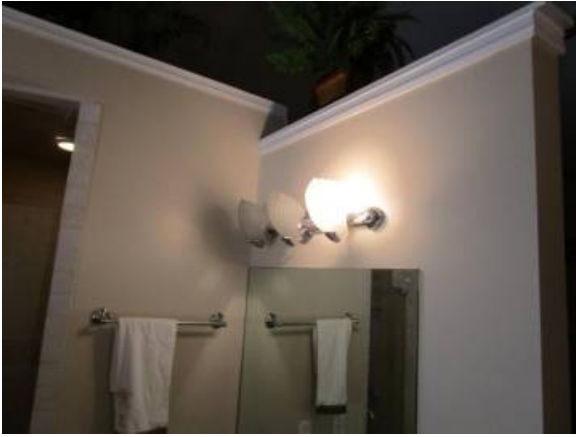
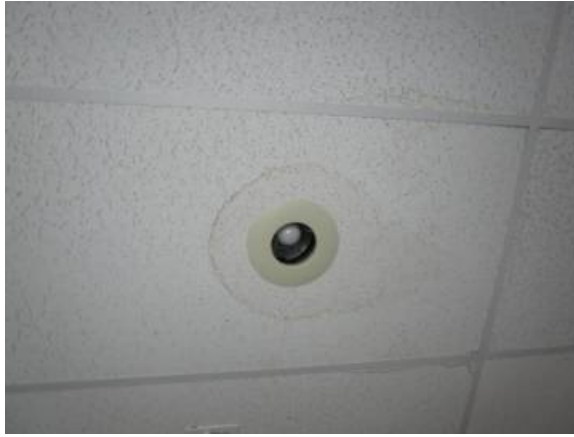
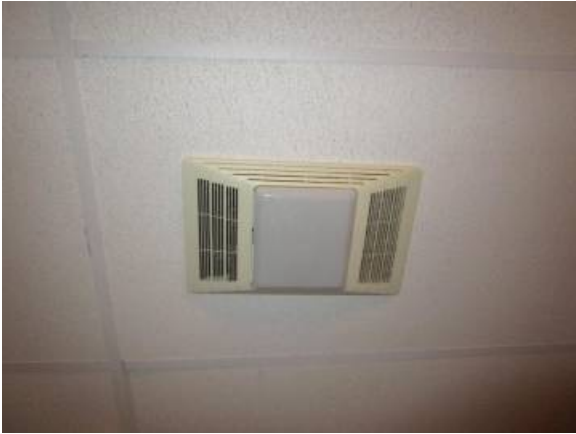
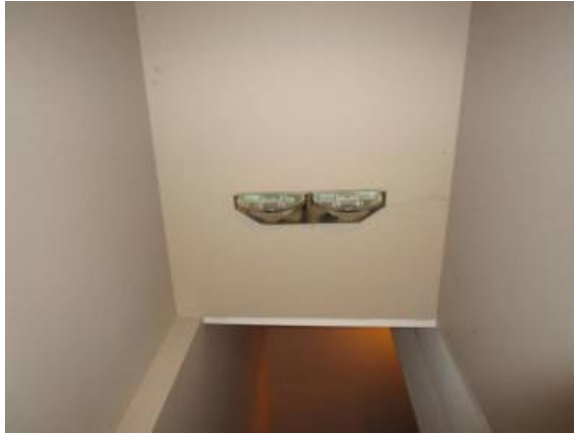
Numerous lighting fixtures did not operate at the time of the inspection using normal controls. This often indicates that light bulbs may be burned out. Recommend checking with the current owner and verifying operation before the closing.

The office fan rubbed the light fixture when turned on making the fan unusable. Recommend further evaluation and repair.

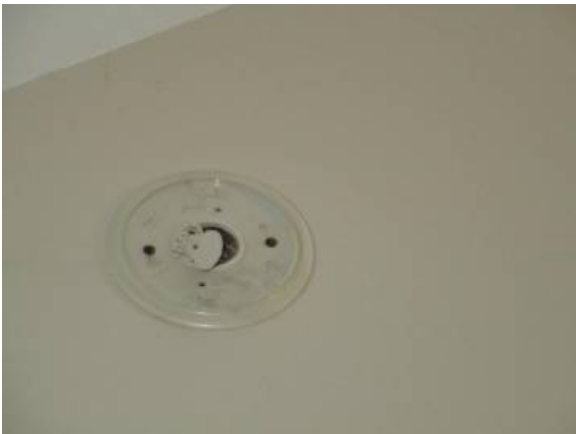
SMOKE DETECTORS

Several of the smoke detectors appeared to be broken, inoperable or missing from their mounts. Repair or replacement is recommended. Dead batteries are often the reason for detectors not working.

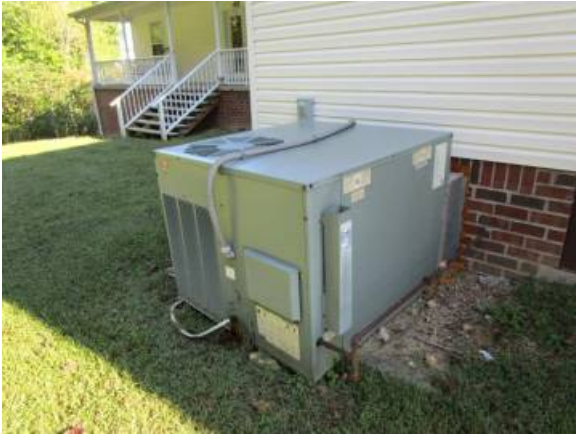
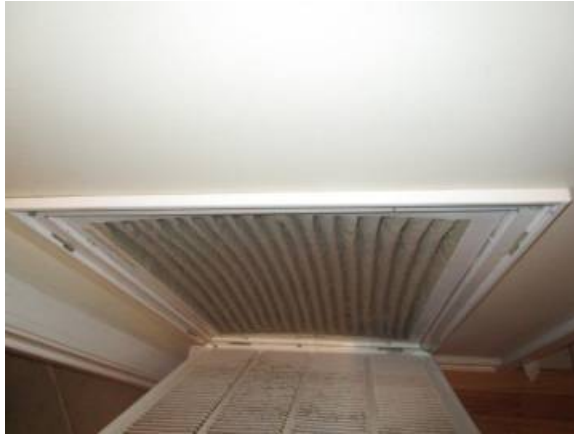
The heating equipment does not appear to have had recent maintenance. Heat exchanger defects may be hidden by dirt, soot or corrosion. Proper cleaning and further evaluation by a qualified heating contractor is recommended.

The gas was shut off at the time of the inspection, and the unit could not be verified for proper operation. Recommend checking with the current owner as to why it was shut off and having the operation of the unit verified.

Forced Air Filter: The air filter(s) was dirty at the time of the inspection. Dirty filters restrict air flow which may cause short cycling and can shorten the life of the heating equipment. Recommend changing (or cleaning, if a reusable type) the filter in accordance with the filter manufacturer's and the heating equipment manufacturer's directions.

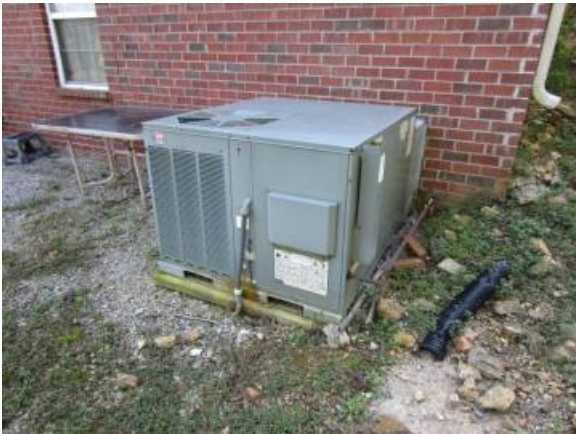
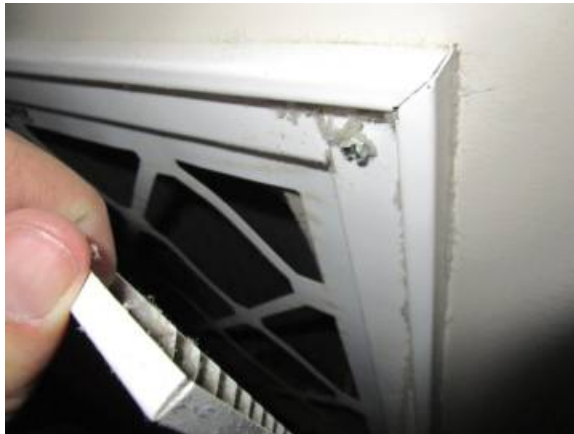
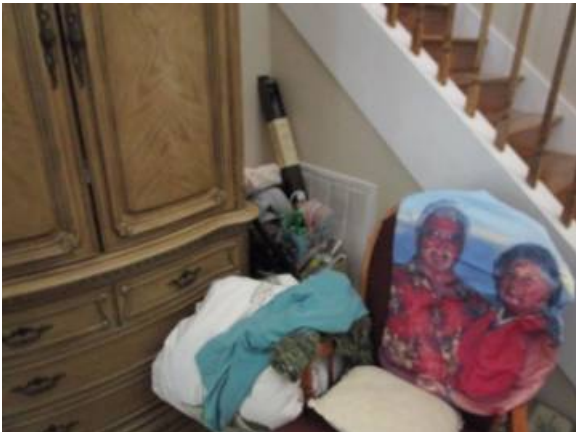
HEATING Unit 2

The heating equipment does not appear to have had recent maintenance. Heat exchanger defects may be hidden by dirt, soot or corrosion. Proper cleaning and further evaluation by a qualified heating contractor is recommended.

The gas was shut off at the time of the inspection, and the unit could not be verified for proper operation. Recommend checking with the current owner as to why it was shut off and having the operation of the unit verified.

Forced Air Filter: The air filter(s) was dirty at the time of the inspection. Dirty filters restrict air flow which may cause short cycling and can shorten the life of the heating equipment. Recommend changing (or cleaning, if a reusable type) the filter in accordance with the filter manufacturer's and the heating equipment manufacturer's directions.

The air filter(s) was loose. The poor fit may allow dust and hair to accumulate and restrict air flow, which in turn may cause short cycling and can shorten the life of the heating equipment. Recommend correction by a qualified heating contractor so that the filter fits properly.

The air return door in the master bedroom appeared to be bent and did not fit properly in the frame. Recommend repair or replace by a qualified contractor.
