*The BrickKicker is pleased to present this
professional home inspection report
for the property located at:*

**XXXXXXX
XXXXXXX, TN 3XXXX**

September 23, 2016

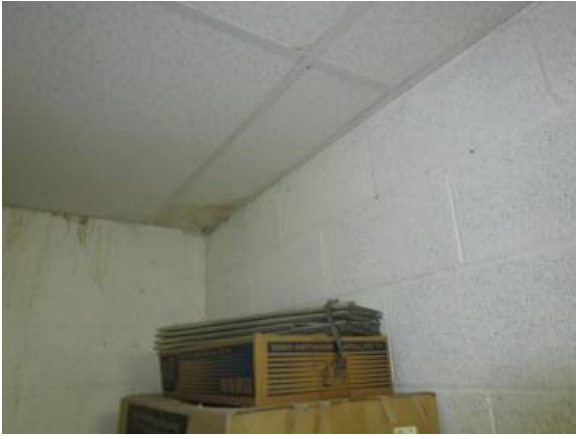
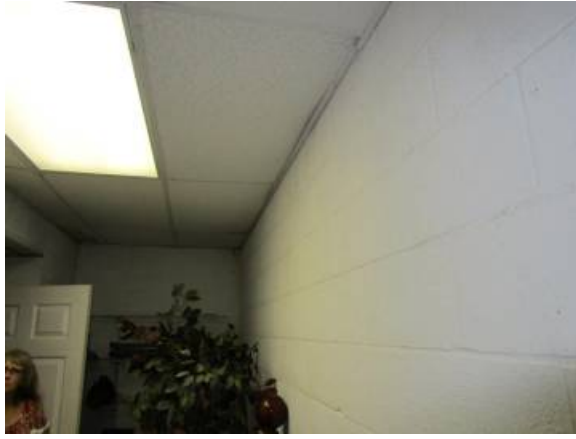
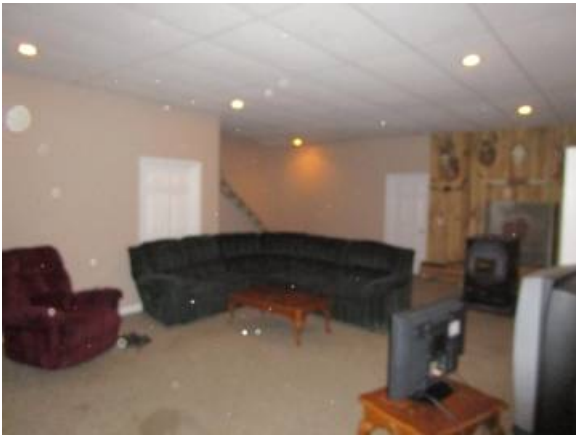
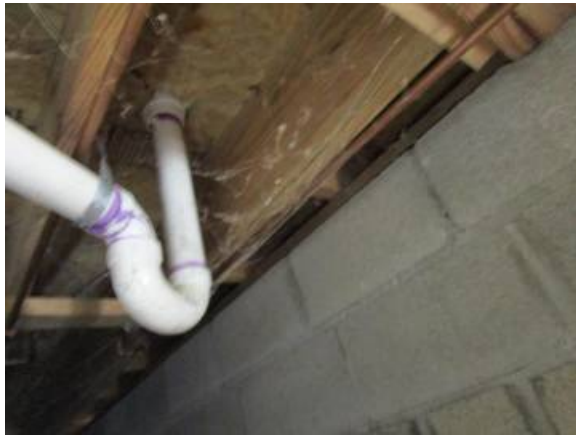
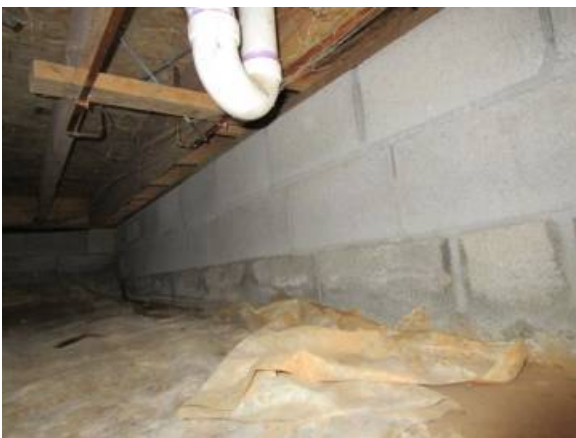
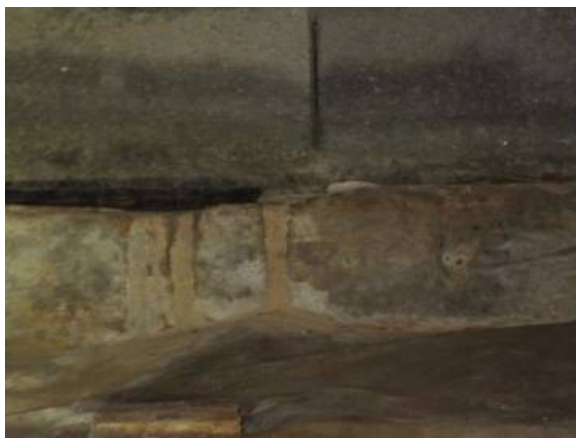
FOUNDATION WALLS

Dampness was noted several areas, as tested with a moisture meter. This can increase the risk of insect infestation, mildew, and rot. Recommend locating and correcting the source of the dampness, which may include improving exterior drainage and/or sealing of foundation cracks.

A dark material that could be mold was noted at several areas of the foundation wall. This is an indication of excess moisture, either from leaks or condensation/humidity. Identification and correction of the moisture source then proper removal of the dark material is recommended however, the actual presence of mold can only be determined by proper testing, which is not a part of this inspection.

Could not reach wall to test for moisture

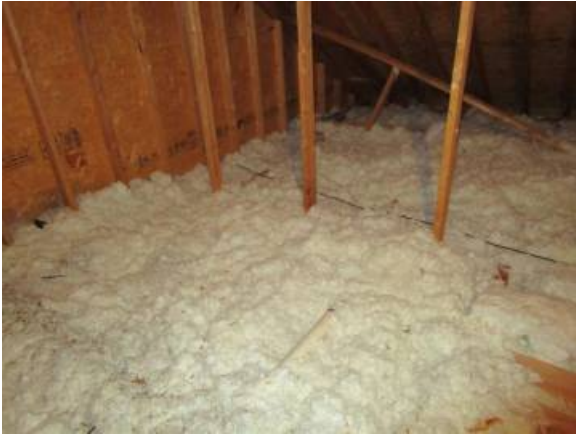
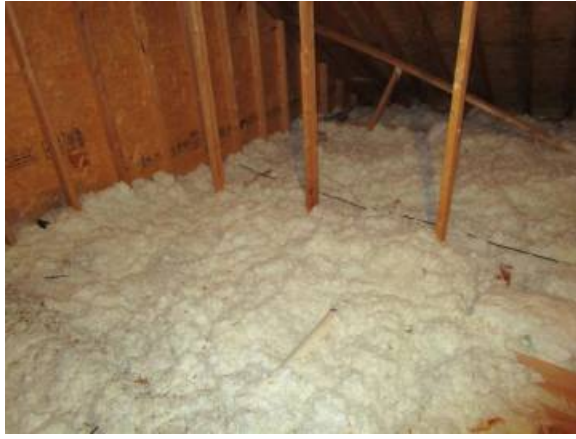
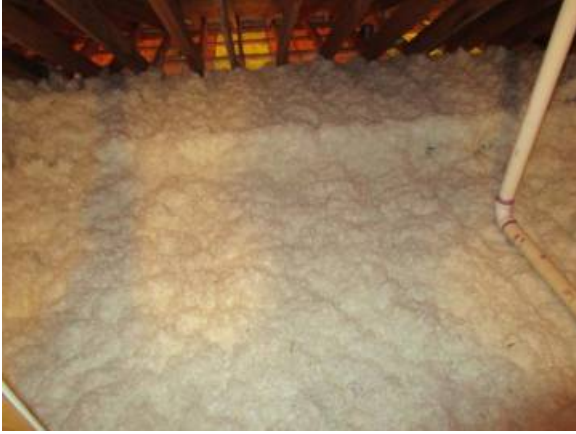
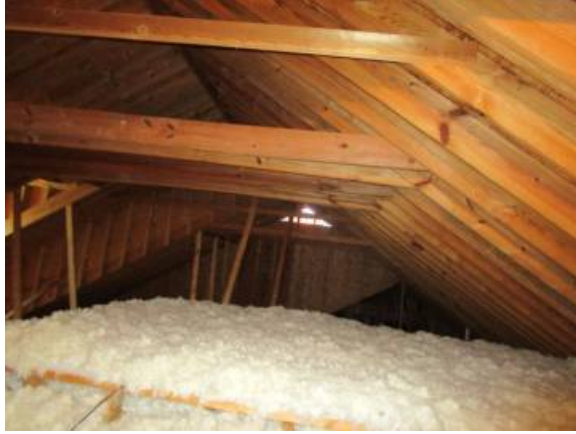
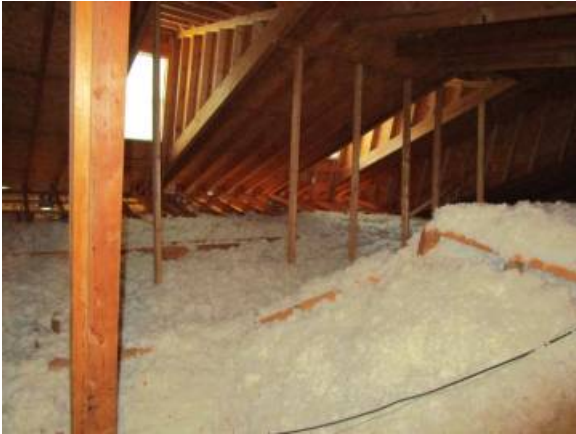
Insulation appeared to be missing in some areas of the attic space(s). Recommend adding insulation to achieve a consistent total depth of 16 inches (the current standard) which will help to provide improved energy efficiency and cost savings.
