# PROPERTY INSPECTION REPORT

**Prepared For: Happy Buyer**

**12/26/18**

**1001 World Center Dr  
Naperville, IL  
60564**

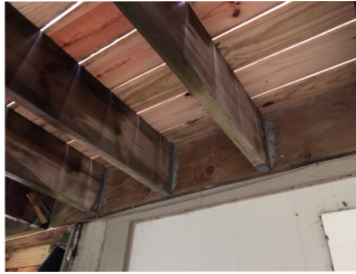
Nailed Ledger

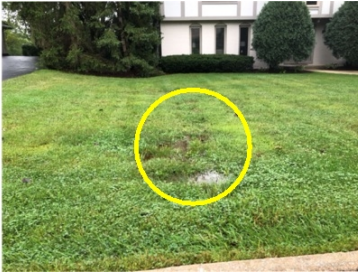
The property would benefit with some re-grading of areas of the front yard to prevent water from standing in the yard.

Low Spot

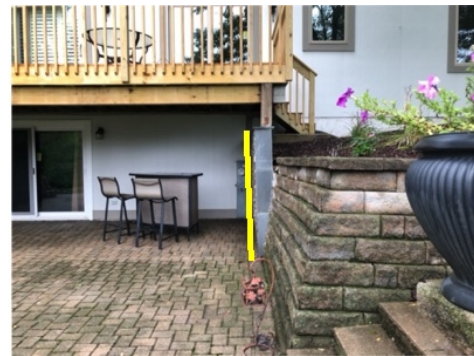
Page 12 Item: 14	Retaining Wall(s)	Possible structural movement was noted at and around the retaining wall(s). Further evaluation by a qualified contractor is recommended to determine what may be causing the movement and as to how repairs should be made.
Page 12 Item: 15	Clothes Dryer Vent	Visible clogging or debris was noted in the exterior portion of the bathroom vent. Professional cleaning is recommended. Clogged vents can be a fire hazard.
<b>Roof</b>		
Page 15 Item: 3	Flashing	Open or damaged areas of flashing, with repair recommended, were noted: at the chimney(s)
<b>Rooms</b>

Leaning Retaining Wall

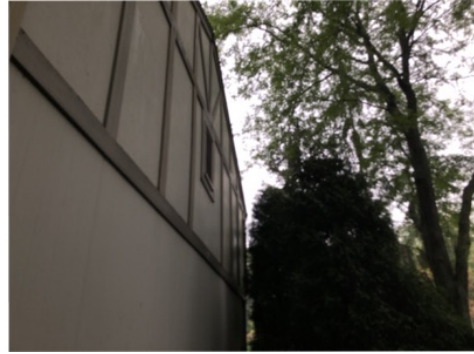
Keep Trees Trimmed

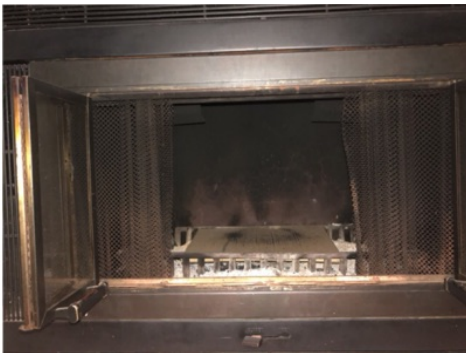
Excessive build-up of soot or creosote was observed in the flue(s) and/or fireplace(s). Creosote is a fire hazard. Cleaning and inspection by a qualified chimney sweep is recommended. Flue or firebox defects may be hidden by soot and creosote.

The flue damper(s) did not operate correctly. Recommend further evaluation and repair by a qualified contractor.

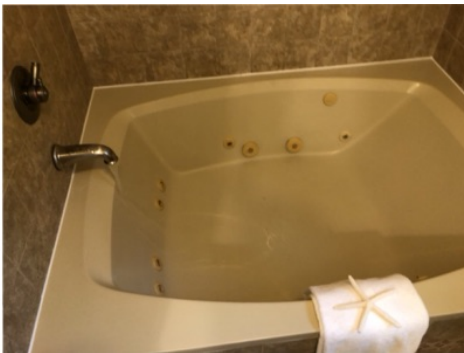
The whirlpool tub was not tested due to the tub stopper missing. Recommend the stopper be repaired and the tub pump motor be reviewed and tested prior to closing.

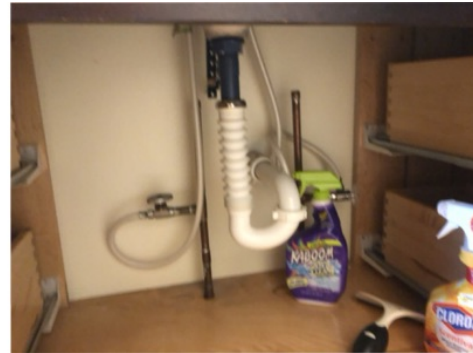
Ribbed Drain Pipe (Left Sink)

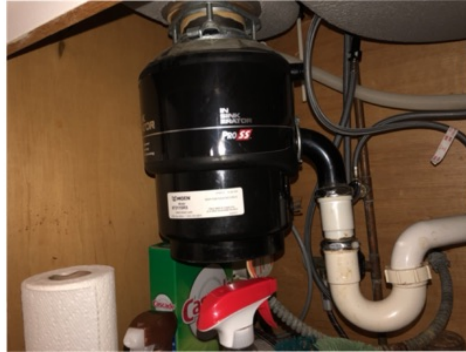
- The appliance operated normally using basic controls at the time of the inspection. Recommend referring to the operational manuals for proper use and care.
- Loose electrical wiring was observed at disposal: Loose electric under a disposal may fail to provide the proper grounding or bonding to safely operated the appliance. Repairs are recommended. See the electrical page of the report under "Branch Circuit Wiring" for more information.

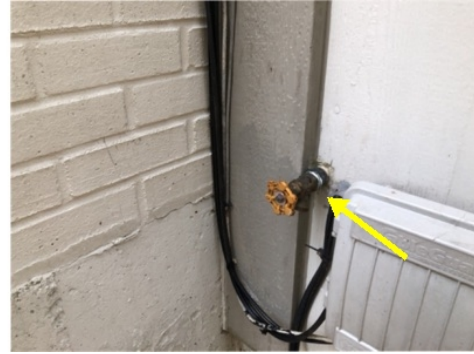
Non-Freeze Protected

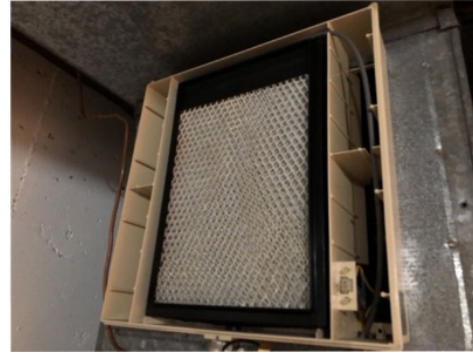
General View of the Humidifier Pad

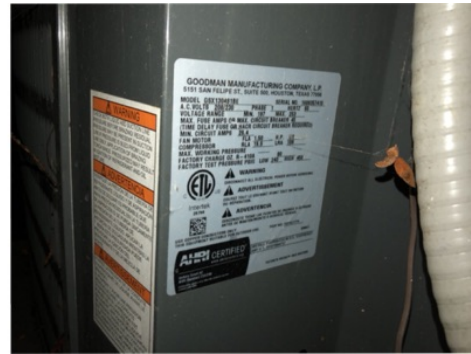
General View of Cooling Unit Label Plate

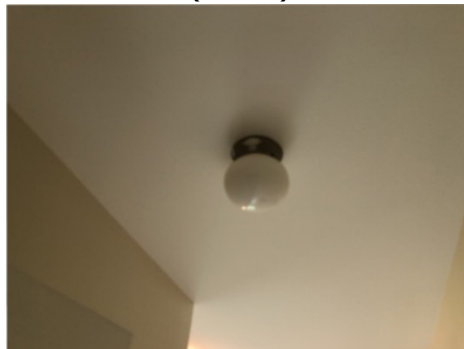
One electrical/lighting fixture in the hallway to the garage did not operate at the time of the inspection using normal controls. This often indicates that light bulbs may be burned out. Recommend checking with the current owner and verifying operation before the closing.

Bad Bulb

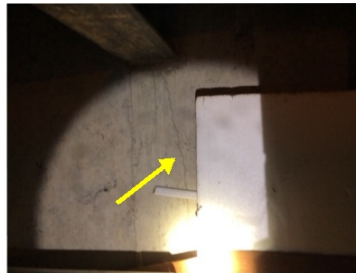
Typical Cracking

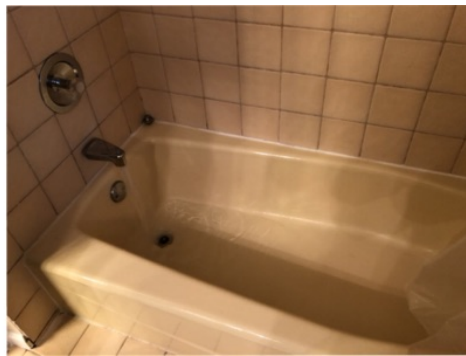
The bathtub was found to have exhibited moderate general deterioration typical for the age of the home or material used. Any deficiencies will be listed in this section.

General View of Bathtub
